CORMAC

MILLBROOK FEASIBILITY STUDY

FEASIBILITY REPORT

Consultancy | AECOM Limited

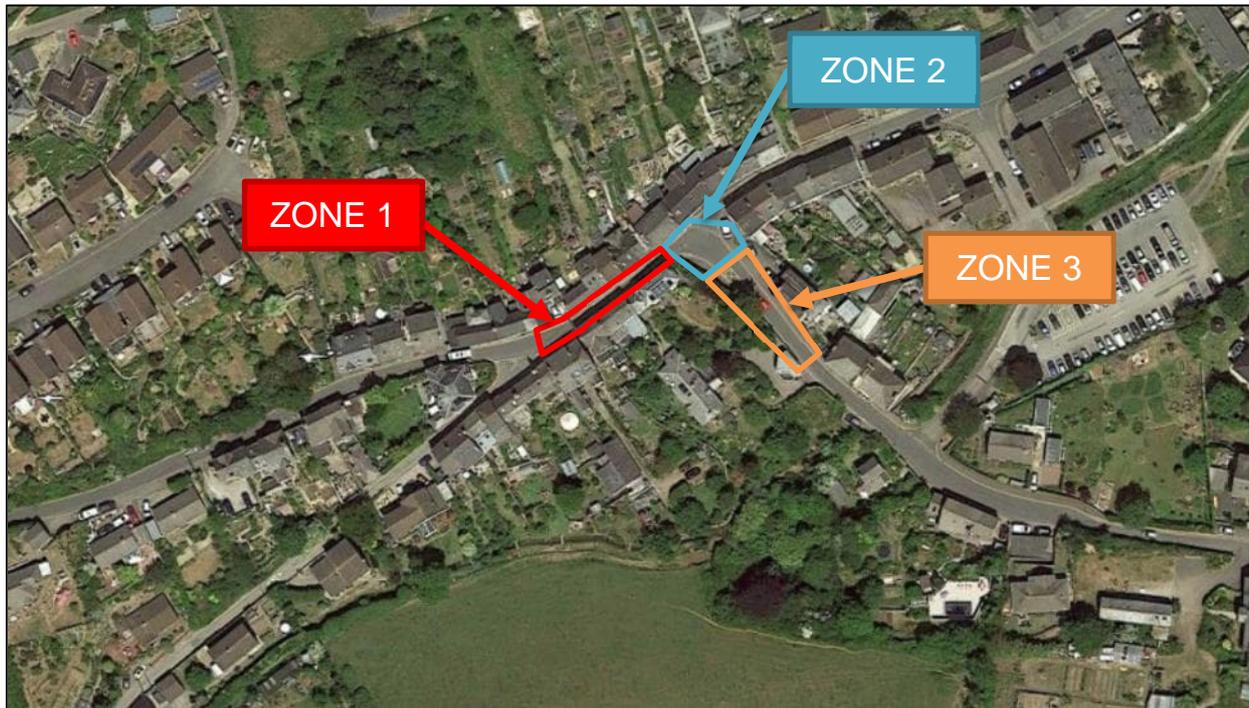
Figure 2 Focus Area of the Study

The area to focus on in the study can be divided into three defined elements (shown in Figure 2 and outlined as follows):

The focus of the study covers the B3247 at Hounster Hill, to the B3247 at the south of Millbrook, joining West Street. The study will focus on an area with an approximate length of 100m off West Street, the B3247 - West Street junction and the B3247 approach to West Street. This is where the issues are located. The methodology of this Feasibility Study will however cover a much greater area, encompassing the surrounding road network, to ensure all potential options are investigated and assessed, to attempt to solve the issues in Millbrook.

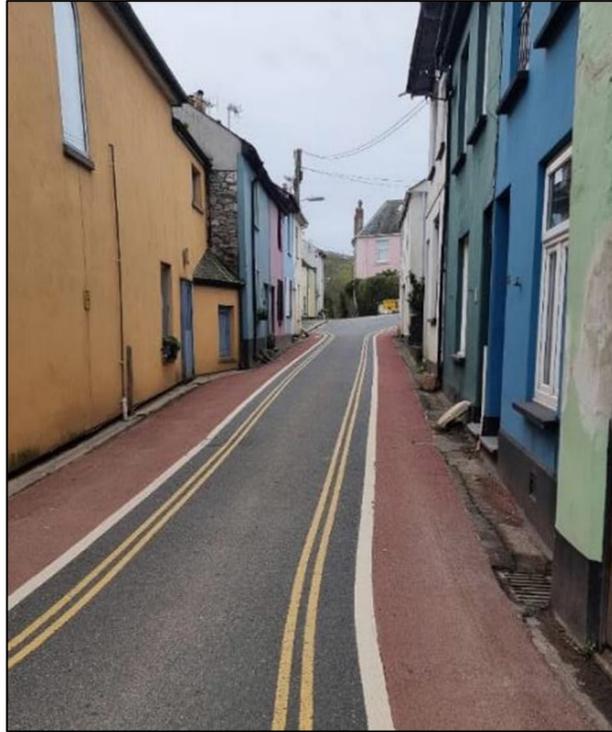
Figure 3 West Street Narrow Section with Virtual Footways (Site visit 17/02/2022)

West Street is a narrow residential street. This zone spans from the B3247 West Street and Radford Lane junction to the B3247 and West Street junction. Due to the reduced space between private properties, the space available in the street is asphalted and predominantly utilised as carriageway. There are painted virtual footways at carriageway level on either side of the street with variable widths of approximately 1.2m. This has been designed to provide pedestrians with enough space to navigate West Street without being forced onto the main carriageway (see Figure 3).

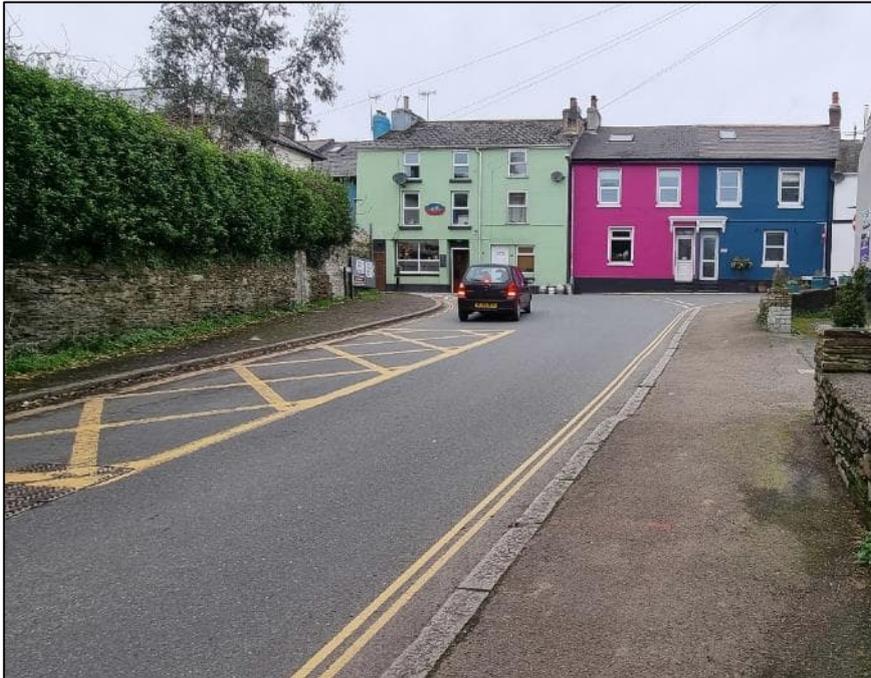
Figure 4 West Street Junction with the B3247, Northbound (Site visit 17/02/2022)

This area is located adjacent to Zone 1 at the east end of the narrow section of West Street. The visibility on this junction is reduced for motorists due to the existing property boundary lines and the sharp horizontal curvature of the road alignment. The junction has a mix of kerbed and painted footways. A yellow box is also located on the west B3247 west to the junction. No waiting at any time restrictions are in place over the whole junction. There is an existing lighting column located between property numbers 67 and 68 on West Street (see [Figure 4](#)).

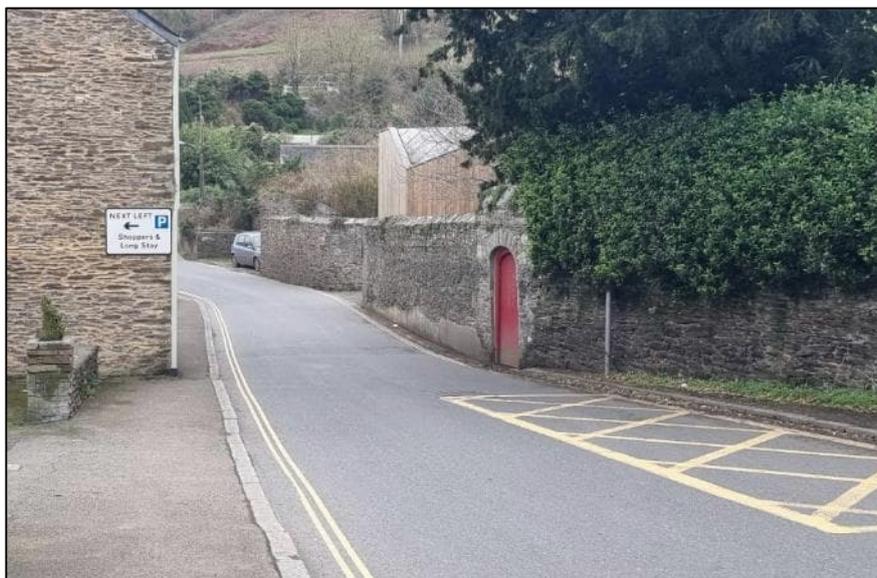
Figure 5 Approach to West Street Junction with the B3247, Southbound (Site visit 17/02/2022)

The northbound approach to the West Street junction along the B3247, south of the yellow box markings is narrow up to the edge of the existing wall on the west side, after which it widens allowing two-way traffic. There is a variable width kerbed footway on one side of the carriageway. No waiting at any time restrictions are in place along the whole study area, and there are no lighting columns in this zone. There is a bus stop near Dodbook House and a yellow box at the end of the junction (see Figure 5).

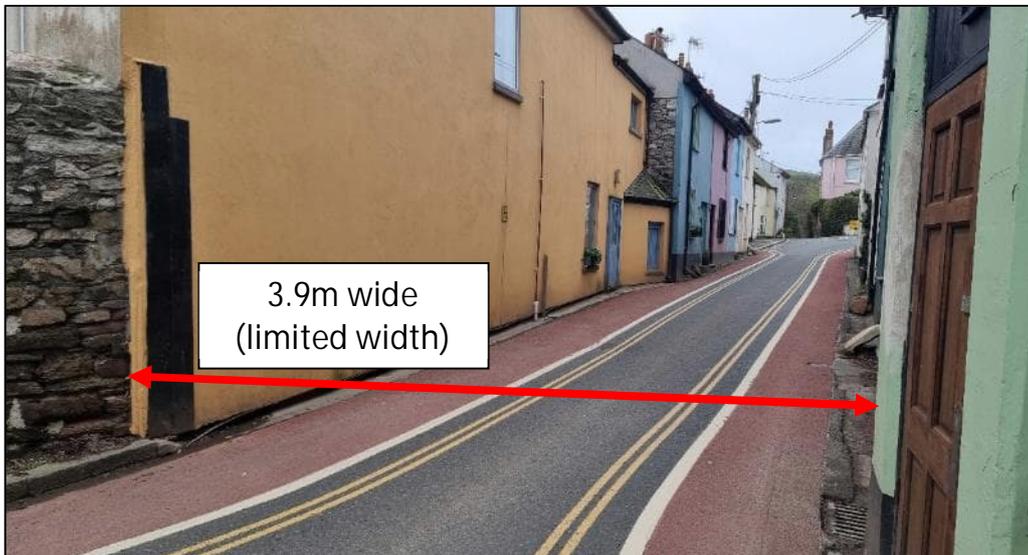
Figure 6 Existing Properties on West Street Constraining Width, East End
(Site visit 17/02/2022)

The existing terraced private properties located either side of West Street are the main physical constraint to this study, as the proximity of the properties forms a very narrow passage. This means any widening of the carriageway is not feasible. As stated in Zone 3 of the study area overview, the B3247 road narrows on the approach to the West Street and B3247 junction and later widens just prior to the yellow box. Following the turning onto West Street, the road reaches its narrowest point of approximately 3.9m width measured from building to building (see [Figure 6](#)). The street widens slightly, however remains narrow, exiting onto Hounster Hill. On the exit, the distance from building to building widens to 4.1m (see [Figure 7](#)). As outlined in [Chapter 3](#), the properties on the approach to West Street from Hounster Hill also create visibility issues. For more information on all site constraints and existing issues, see [Appendix A](#).

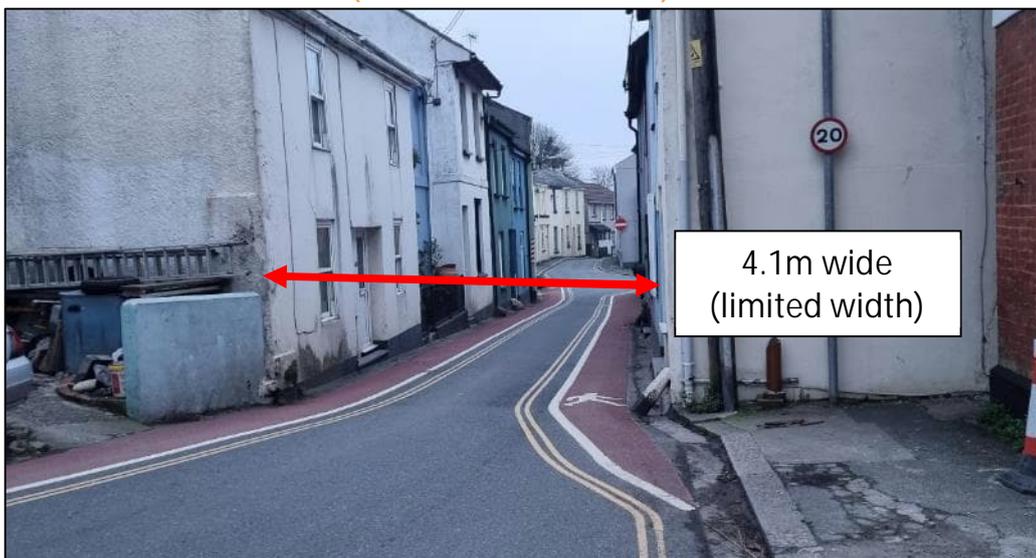
Figure 7 Existing Properties on West Street Constraining Width, West End
(Site visit 17/02/2022)

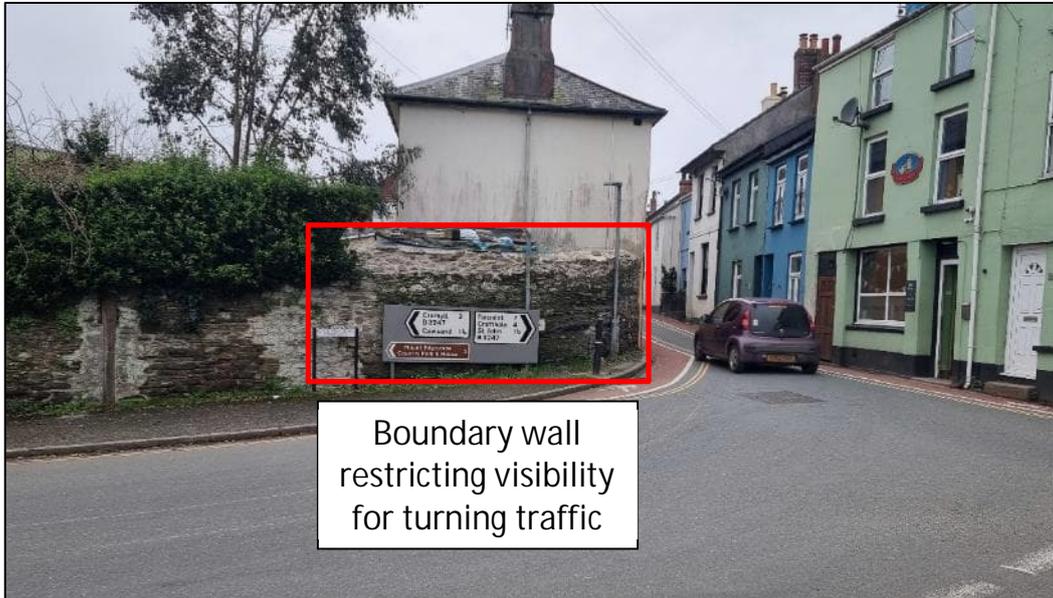
[Figure 8](#) Boundary Wall on South Side of West Street at B3247 Junction (Site visit 17/02/2022)

In addition to the narrow street, the other key constraint is the existing wall on the south side of the B3247 – West Street junction. This wall acts as a boundary for a property and creates exceptionally limited visibility for vehicles turning onto the B3247 West Street from the B3247 (see [Figure 8](#)). A visibility assessment has been undertaken in [Chapter 4](#) to provide insight into the situation for turning traffic.

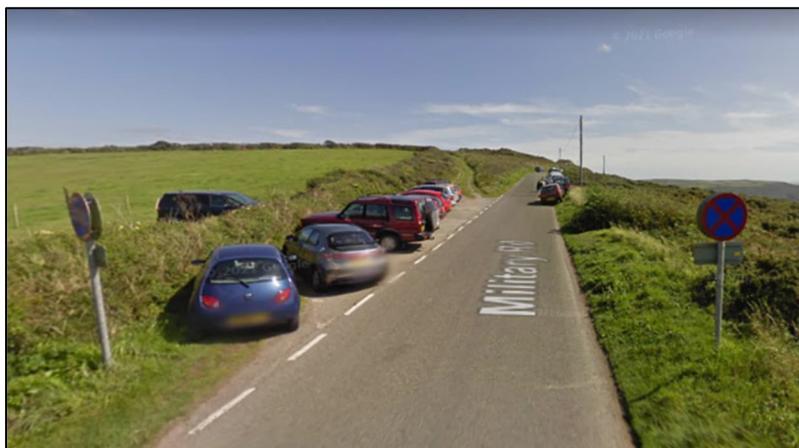
[Figure 9](#) Military Road; Parked Vehicles and Narrow Width (Google Streetview, 2011)

It is apparent from the desktop study that the road network surrounding Millbrook village generally consists of narrow lanes, which are not suitable for use by HGVs. In addition, the lanes have sharp bends with limited forward visibility, parked vehicles on the sides of the carriageway and overgrown vegetation. These roads include: Military Road, Donkey Lane, Forder Hill, Hat Lane and Rame Lane. Examples are shown in [Figure 9](#) and [Figure 10](#). This has been investigated further in [Chapter 4](#).

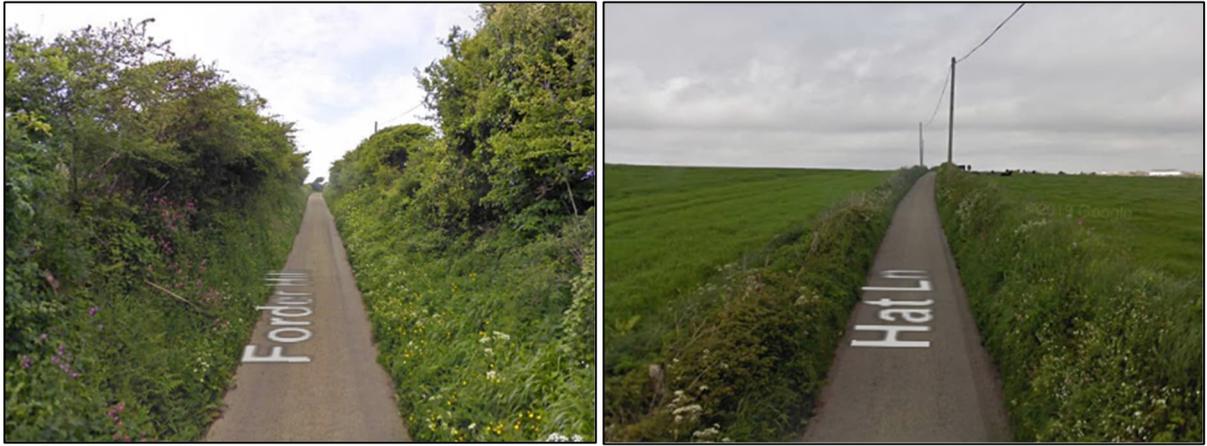
Figure 10 Forder Hill (left); Steep, Overgrown Vegetation and Narrow Width. Hat Lane (right); Narrow Width (Google Streetview, 2009)

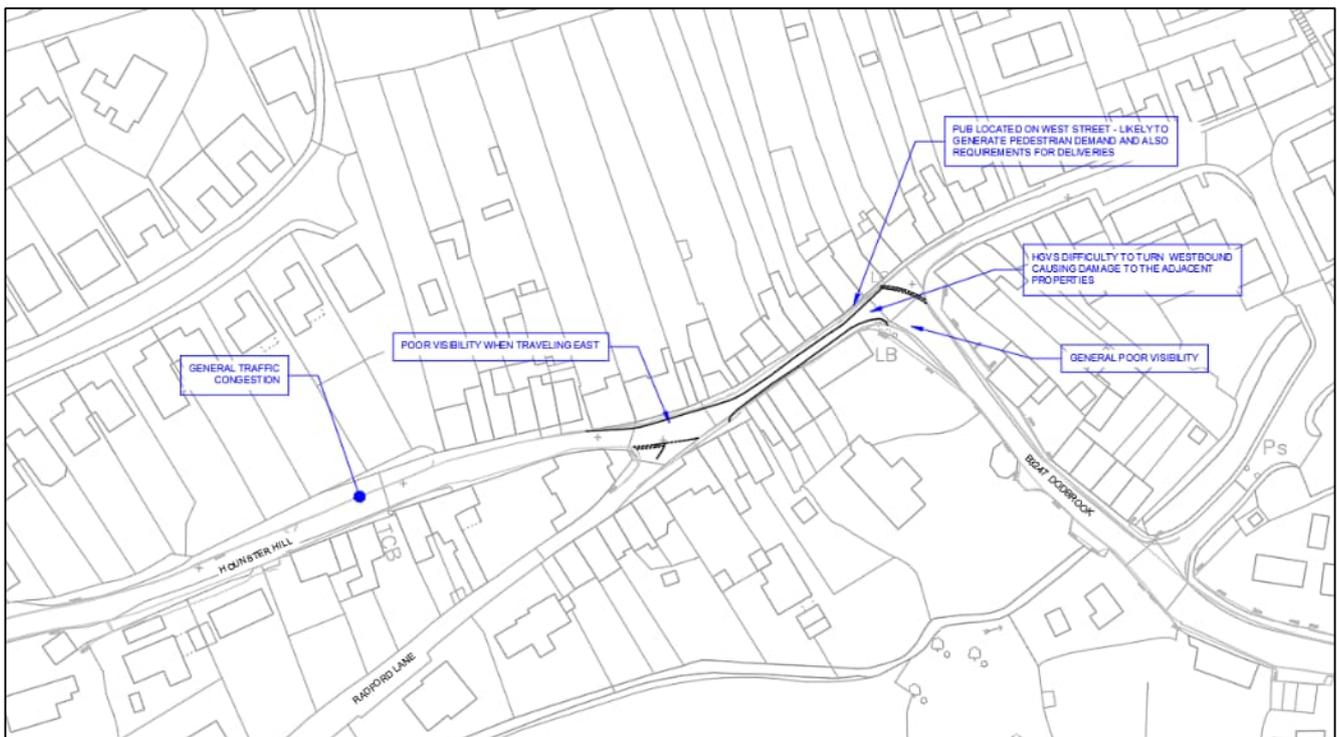
Figure 11 Issue identification in Millbrook

Identified issues in the area are presented in Figure 11 and are discussed in more detail:

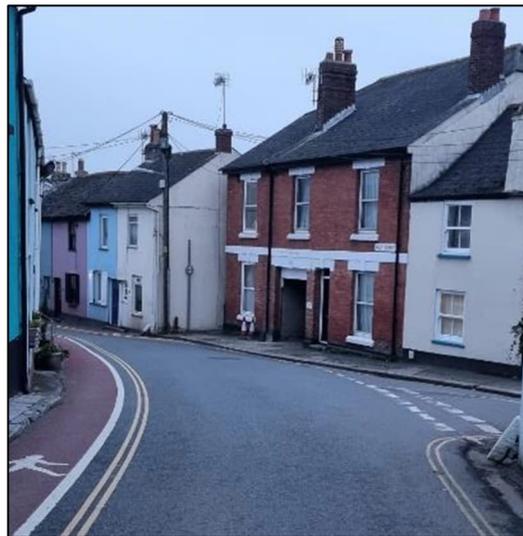
Figure 12 Visibility Towards West Street from Hounster Hill (Site visit 17/02/2022)

Travelling eastbound from Hounster Hill to West Street, clear visibility cannot be achieved. This is due to the curvature and narrowness of the road, in addition to the residential properties restricting the view around the bend.

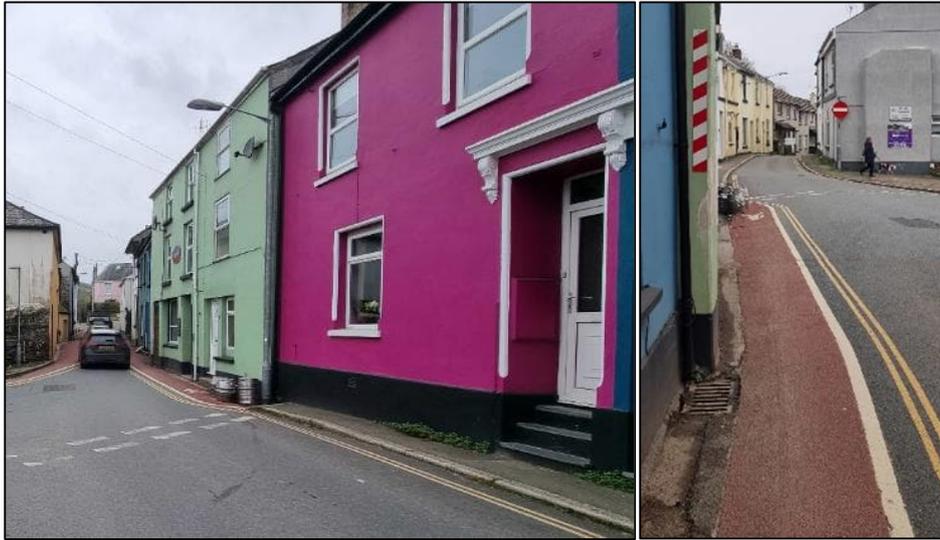
Figure 13 Virtual Footways on West Street are Narrow and in Poor Condition
(Site visit 17/02/2022)

'Bar Tusker' is located on the B3247 – West Street junction, as well as shops and businesses being based further east of the junction. Along with residential properties on the street, this generates pedestrian flows in the area. The current condition of the NMU facilities is not sufficient at providing a safe environment for walking or cycling. The virtual footways along West Street's narrowest section are intended to provide NMUs with a safe space. However, it provides a false sense of security, as large vehicles such as the HGVs still encroach over footways (see Figure 14). There are no protective features provided to ensure a safe environment. In addition, there are no crossing facilities where pedestrians can safely cross the carriageway.

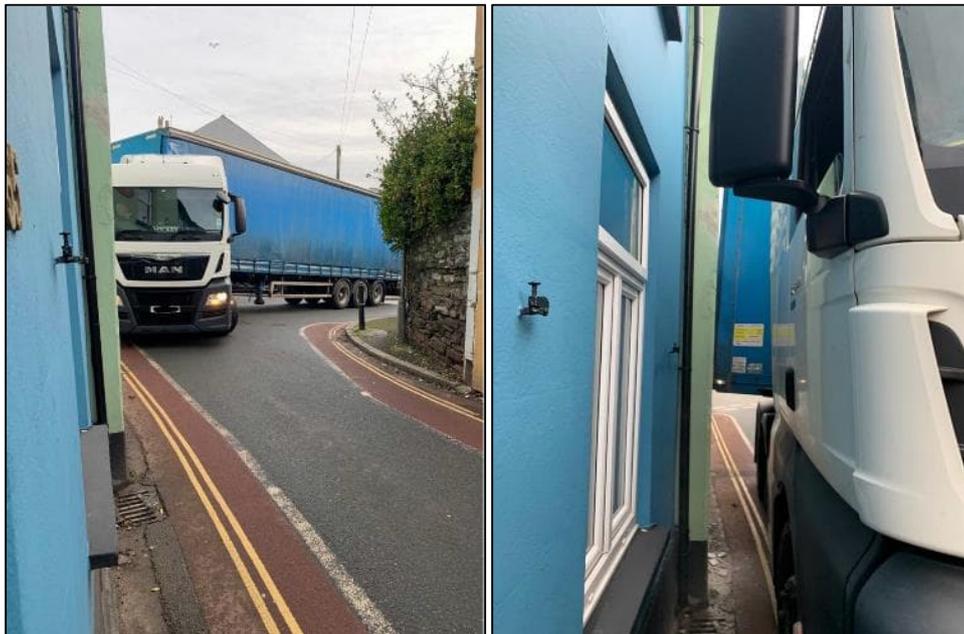
Figure 14 Westbound Articulated HGV of Max UK Length (16.5m) Turning at Bend on B3247
- West Street Junction

Adjacent properties have been damaged by passing HGVs. An example of an HGV turning is shown in Figure 14, and see Figure 15 for property damage caused by an HGV, which was reported to Millbrook Parish Council by local residents.

appears to have less difficulty to make the manoeuvre in one movement at both 5mph and 10mph. However, in both directions, the total clearance of the vehicle is inadequate and risks potential harm to virtual footway users and potential damage to structures, where higher speeds above 10mph would appear to result in damage to property. It is important to mention that while the 16.5m articulated HGV could not be successfully tracked in the westbound direction without issues, there is evidence that suggests these types of HGVs can make the manoeuvre (see [Figure 14](#)), while showing close contact with structures.

While there appears to be no evidence from the camera survey that HGVs of length 16.5m pass through the B3247 – West Street junction, other evidence from police reports (example shown in [Figure 14](#)), provide instances that such vehicles have passed through Millbrook. Where facilitated discussions may take place, the DSP could be used to form part of the agreement. The result of the DSP may reduce the number of larger HGVs using smaller vehicles, which may result in an overall reduction of larger HGVs in the area, therefore benefitting the environment.

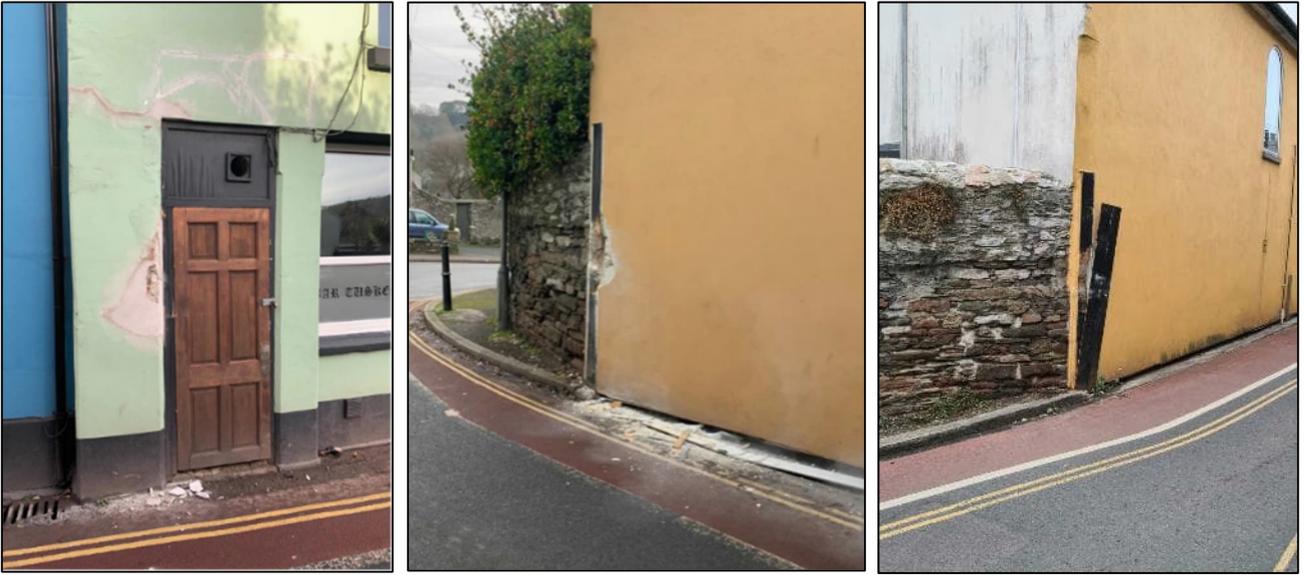
Figure 15 - Property Damage Caused by HGVs on West Street

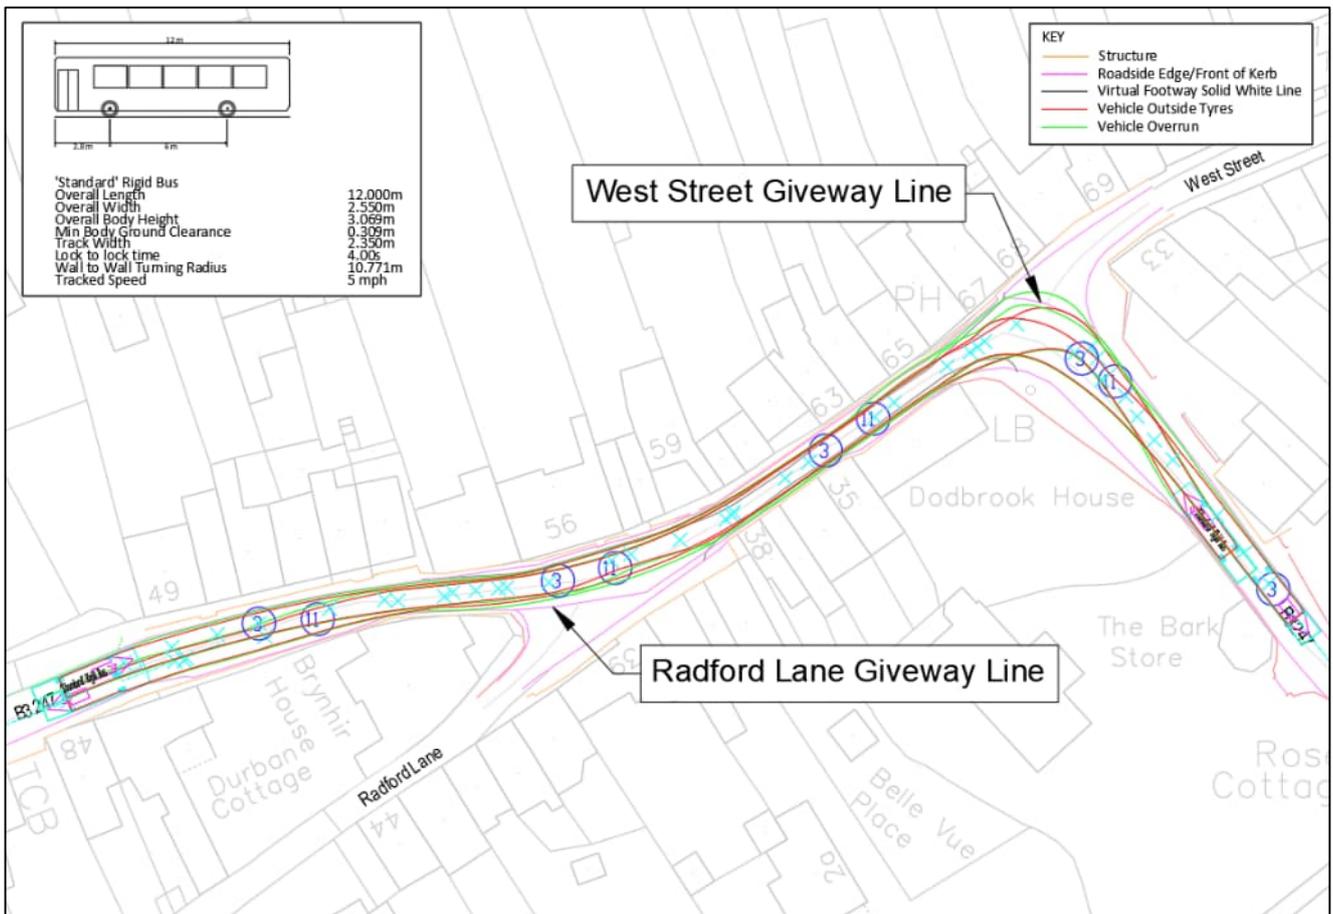
Figure 16 Standard Rigid Bus Tracked at 5mph

Vehicle tracking at the West Street and B3247 junction have been produced for 5mph, 10mph, 15mph and 20mph (excluding the articulated vehicle, which was only tracked at 5 and 10mph) for eastbound and westbound movements. See following [Figures 16 to 25](#).

The 10m standard rigid bus appears to have issues navigating the B3247 – West Street in the westbound direction. At 5mph (see Figure 16) it comes close to mounting the kerb by the property wall and comes very close to the surrounding properties at the entrance of B3247 West Street, as well as property number 67 and 'Bar Tusker', which are facing the westbound approach to the bend. At a speed of 10mph (Figure 17), the westbound bus overruns the West Street give way line at the junction, which possibly risks a collision with a stationary vehicle. At speeds above 10mph (see Figure 18 and Figure 19), the westbound bus appears to likely mount the footway and strike a structure at the entrance of the B3247 West Street. Compared to the westbound, the eastbound bus at 5mph (see Figure 16), 10mph (see Figure 17 and Figure 18), appears to be able to make the turn at the B3247 – West Street junction without any issues. At 20mph (see Figure 19) and even possibly at 15mph, it appears likely the westbound bus may mount the kerb on the south-east side of the junction. Along the whole section in both directions, the total clearance of the bus appears to be inadequate and risks harm to virtual footway users and damage to structures, where higher speed limits above 10mph would appear to possibly result in damage to property.

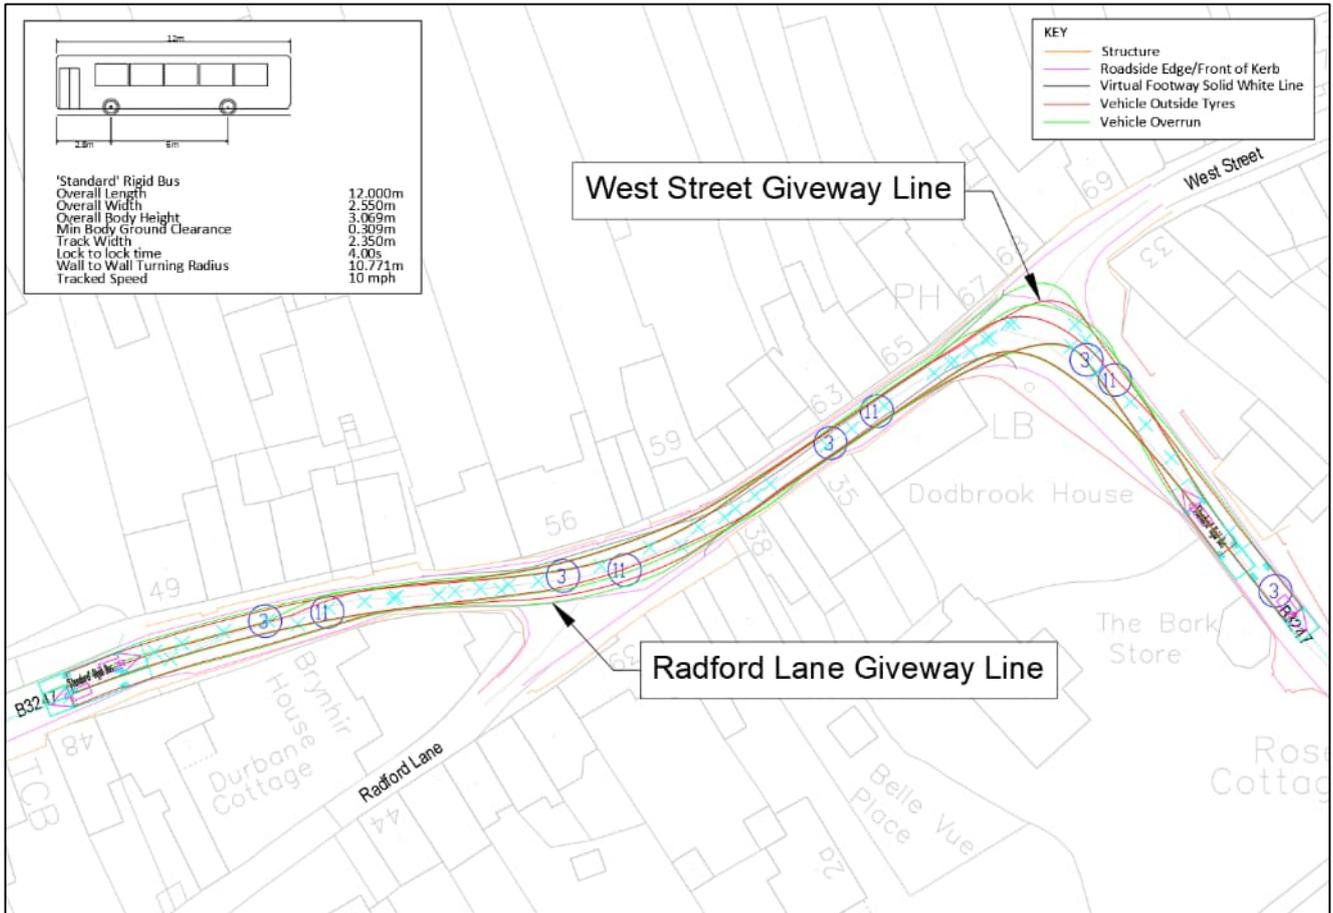
Figure 17 Standard Rigid Bus Tracked at 10mph

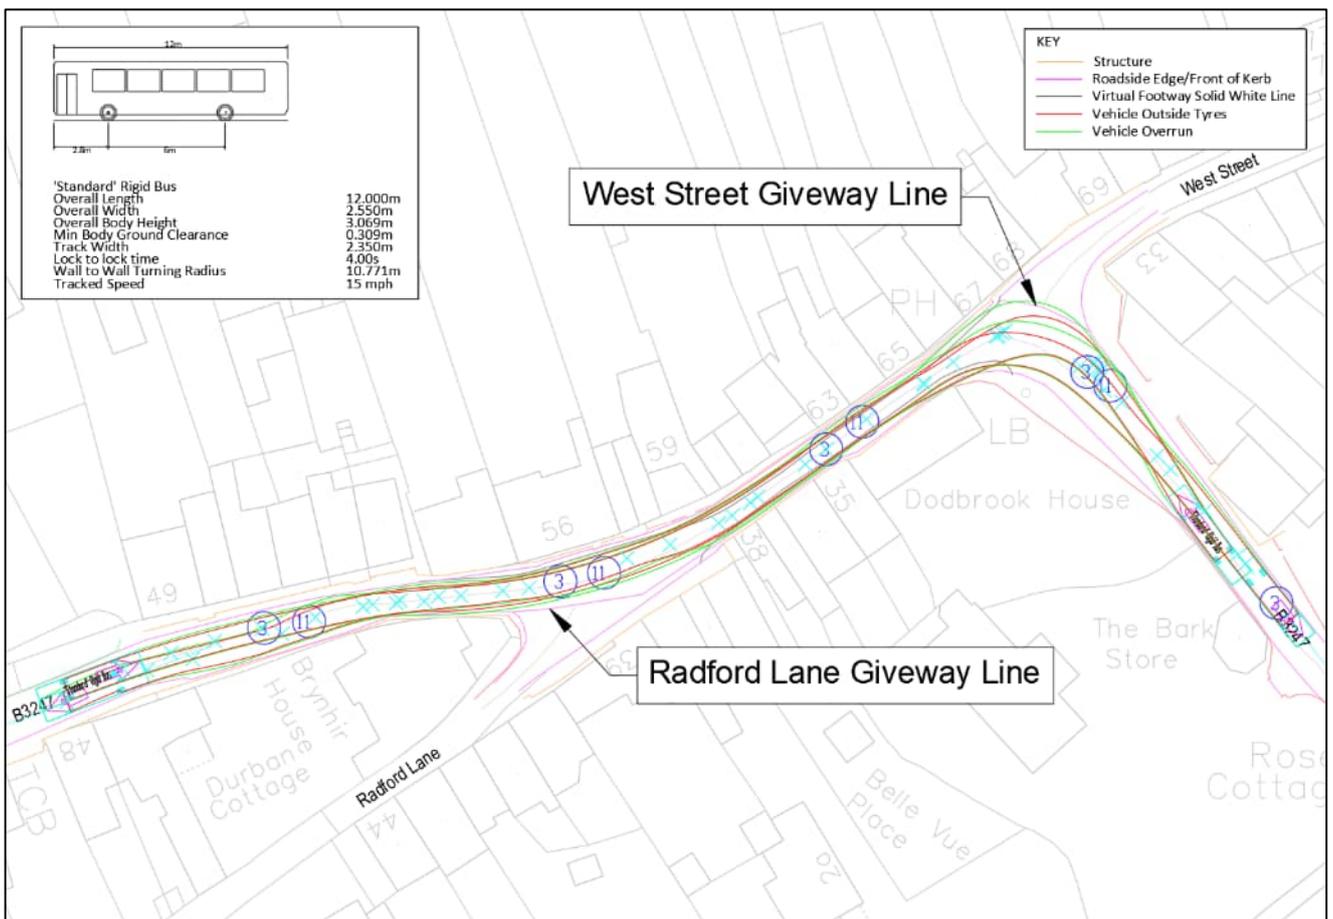
Figure 18 Standard Rigid Bus Tracked at 15mph

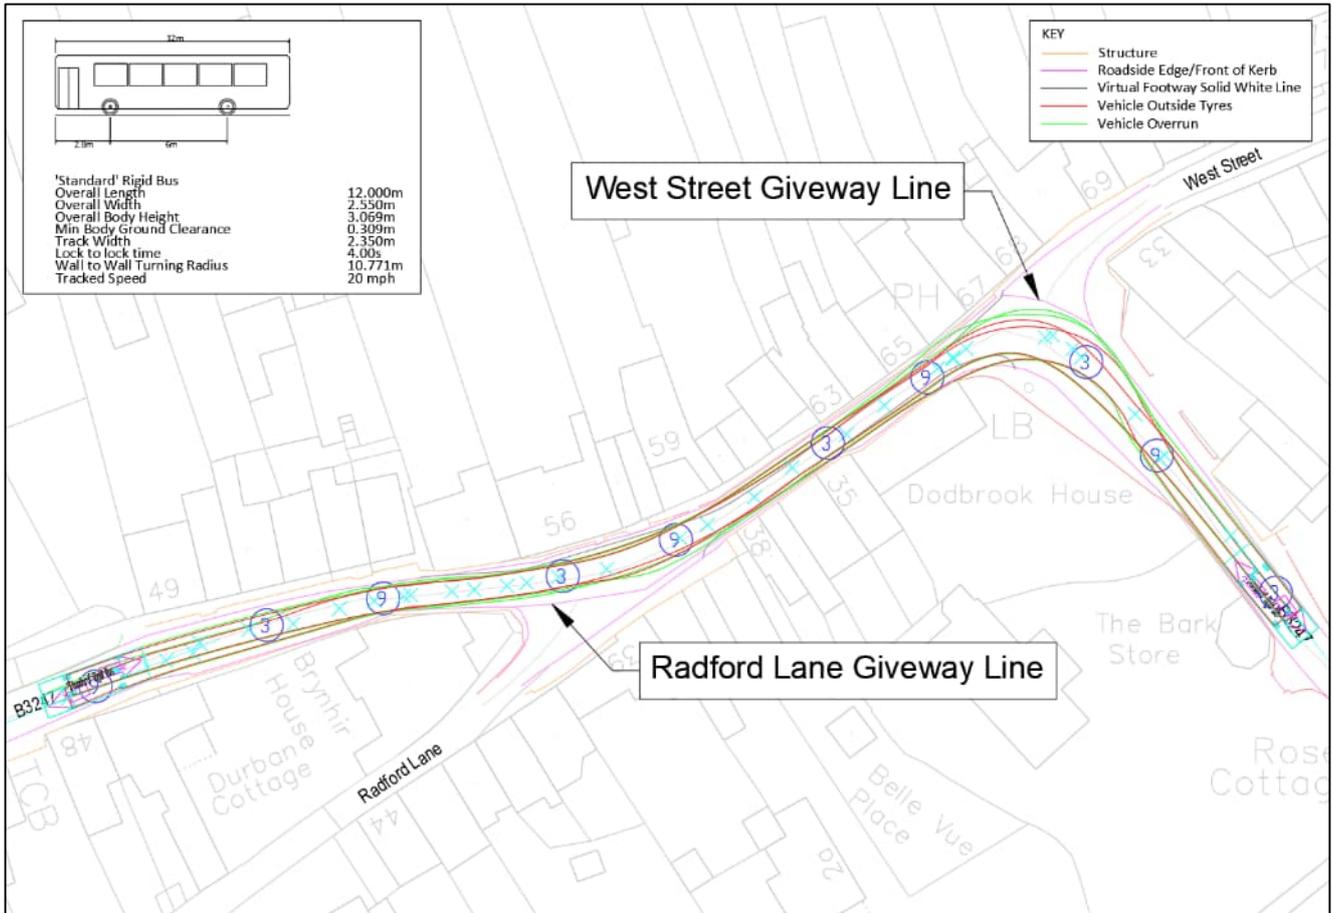
Figure 19 Standard Rigid Bus Tracked at 20mph

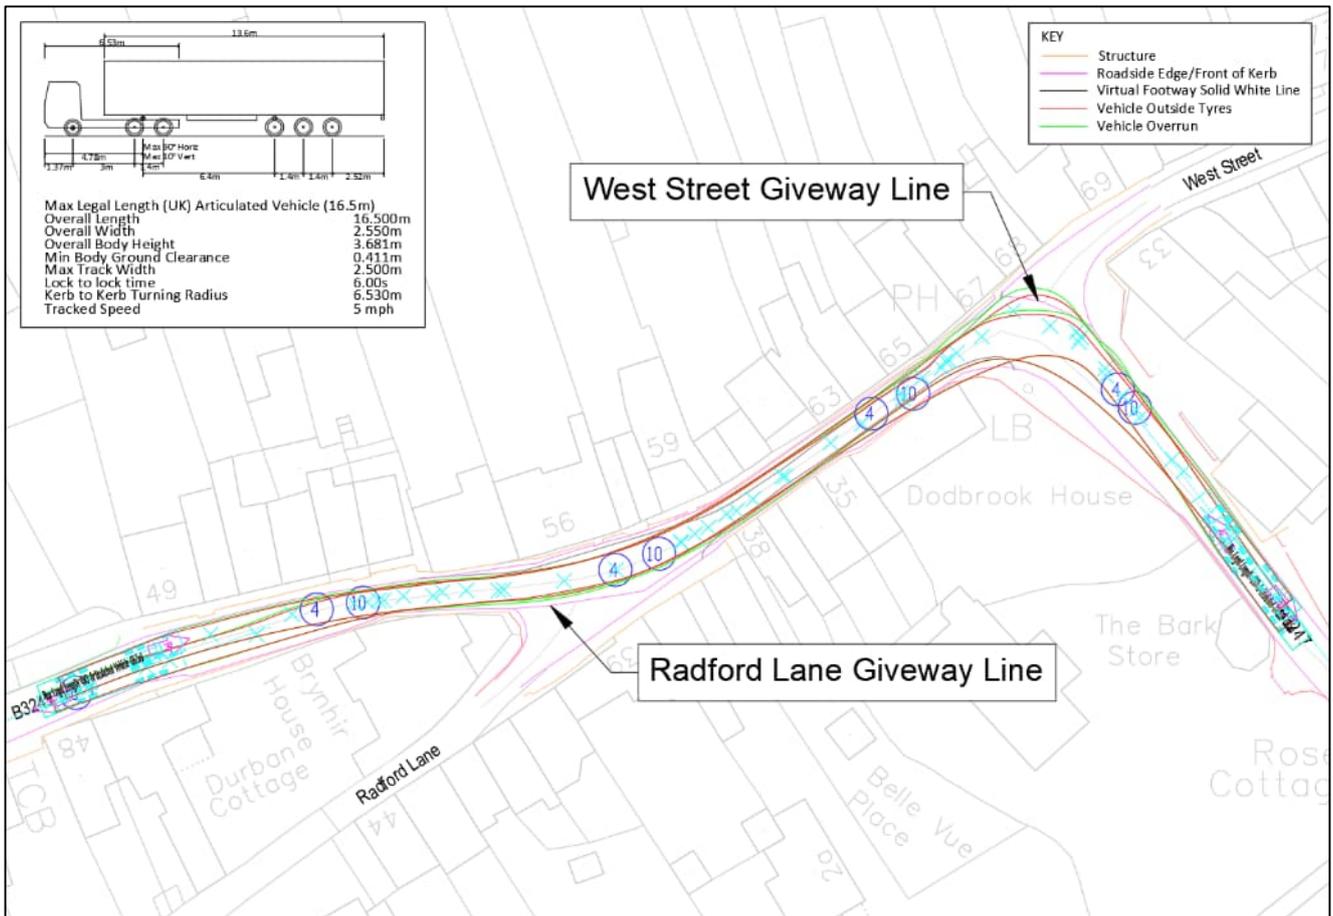
Figure 20 Articulated HGV of Max UK Length (16.5m) Tracked at 5mph

The reason why the 16.5m articulated HGV was not tracked above 10mph, is that at both 5mph and 10mph, it can be observed that in the eastbound and westbound directions, the vehicle is already in close proximity to the structures along the B3247 West Street. This also includes property number 67 and 'Bar Tusker', where there is no room to keep a suitable distance away from the structures. It has been identified for where the articulated HGV is travelling westbound at 5mph (see Figure 20) and 10mph (see Figure 21) that there is not enough space in the road to make the turn in one movement. On the other hand, the eastbound HGV traffic

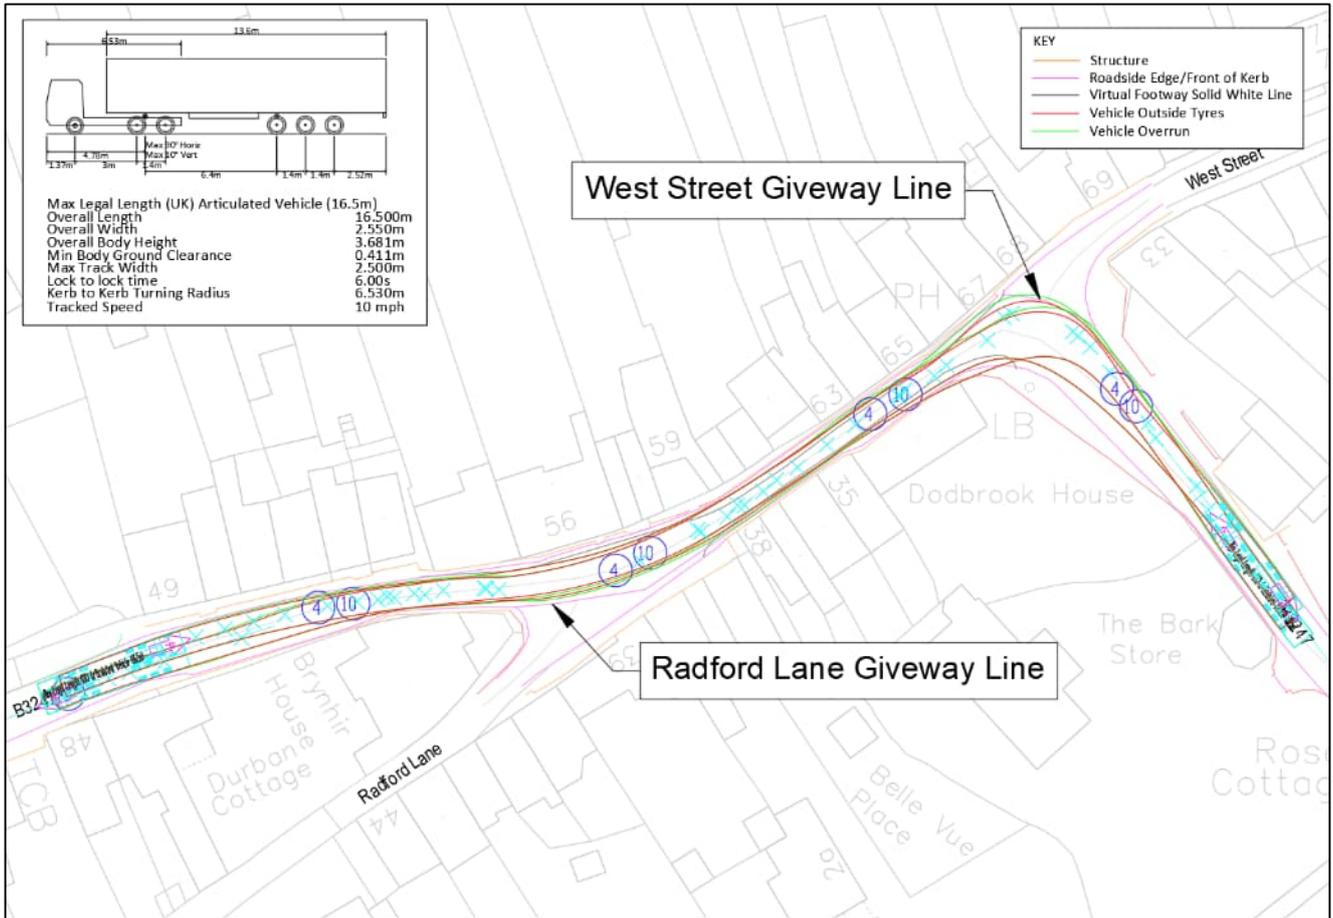
Figure 21 Articulated HGV of Max UK Length (16.5m) Tracked at 10mph

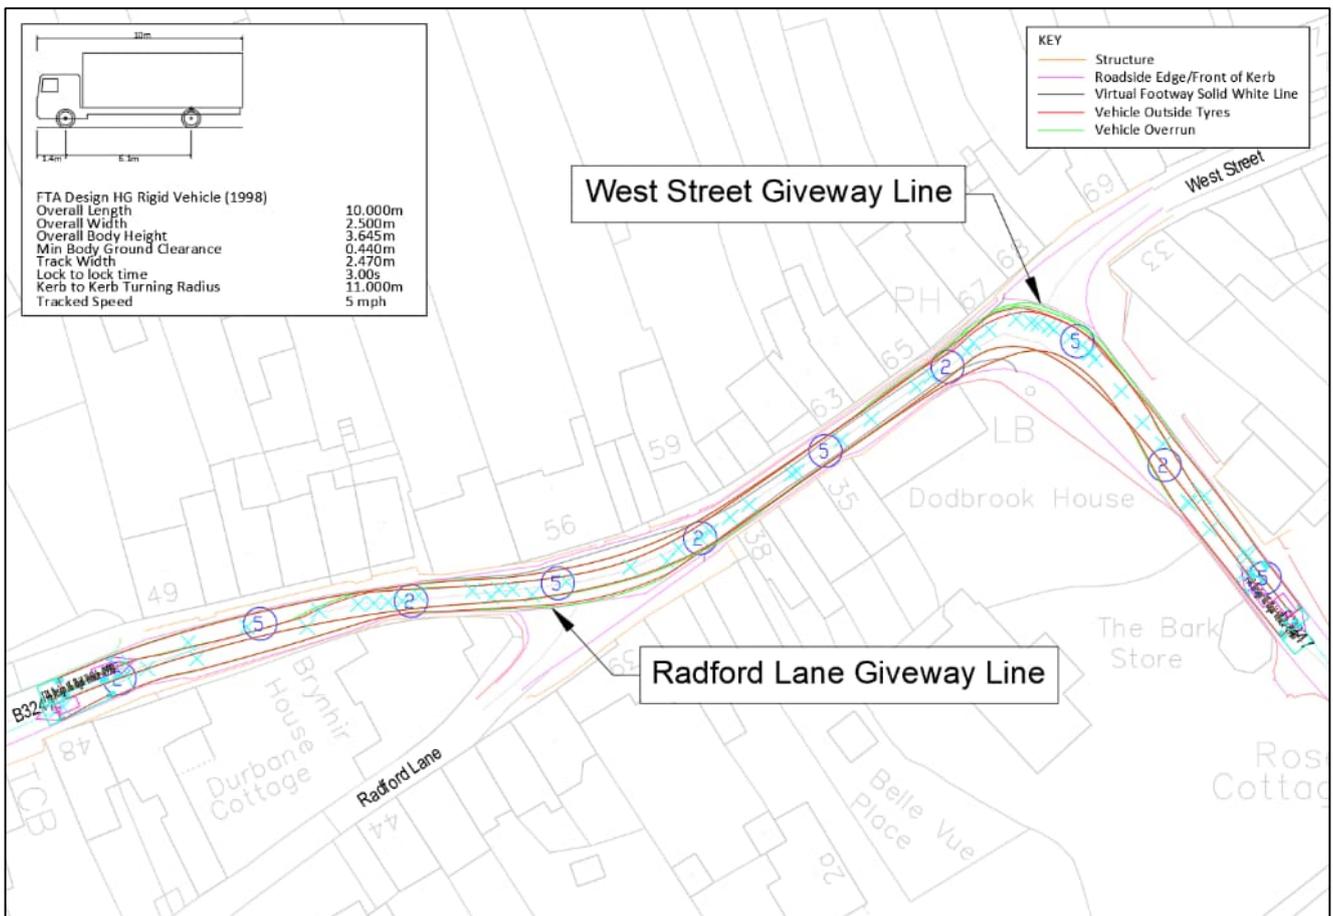
Figure 22 Rigid HGV Tracked at 5mph

Compared to the 16.5m articulated HGV and bus, the 10m rigid HGV appears to have no issue with navigating the bend at the B3247 – West Street junction in both directions. At 5mph (see [Figure 22](#)), 10mph (see [Figure 23](#)) and 15mph ([Figure 24](#)), the vehicle appears to have far less trouble navigating the bend at the B3247. On the other hand, like the other two vehicles; at all speeds, the westbound vehicle comes very close to property number 67 and ‘Bar Tusker’. While it appears that at 20mph (see [Figure 25](#)), the vehicle can make the turning manoeuvre at the junction, it appears to come very close to the surrounding structures which is by no means acceptable.

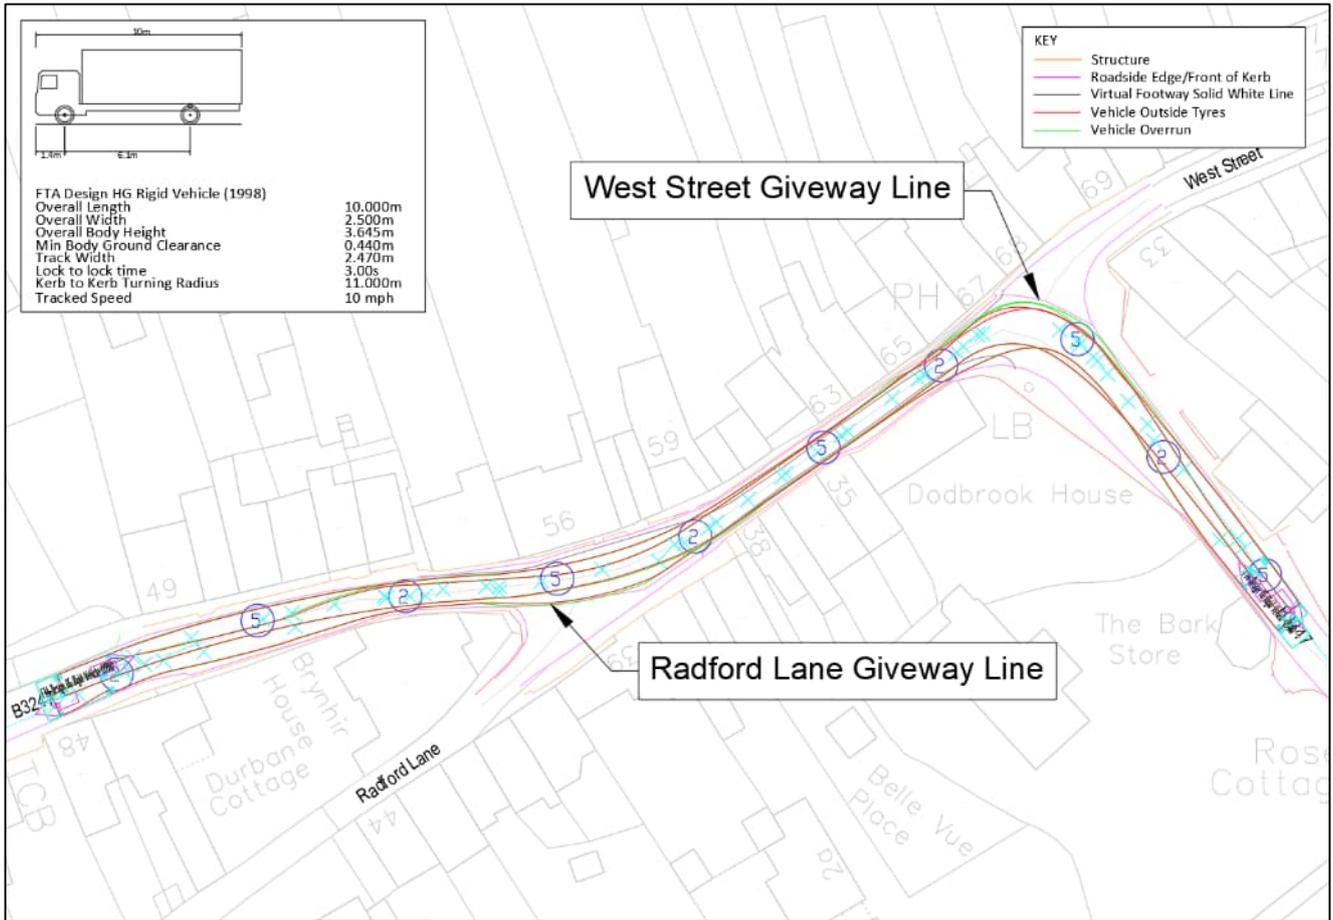
Figure 23 Rigid HGV Tracked at 10mph

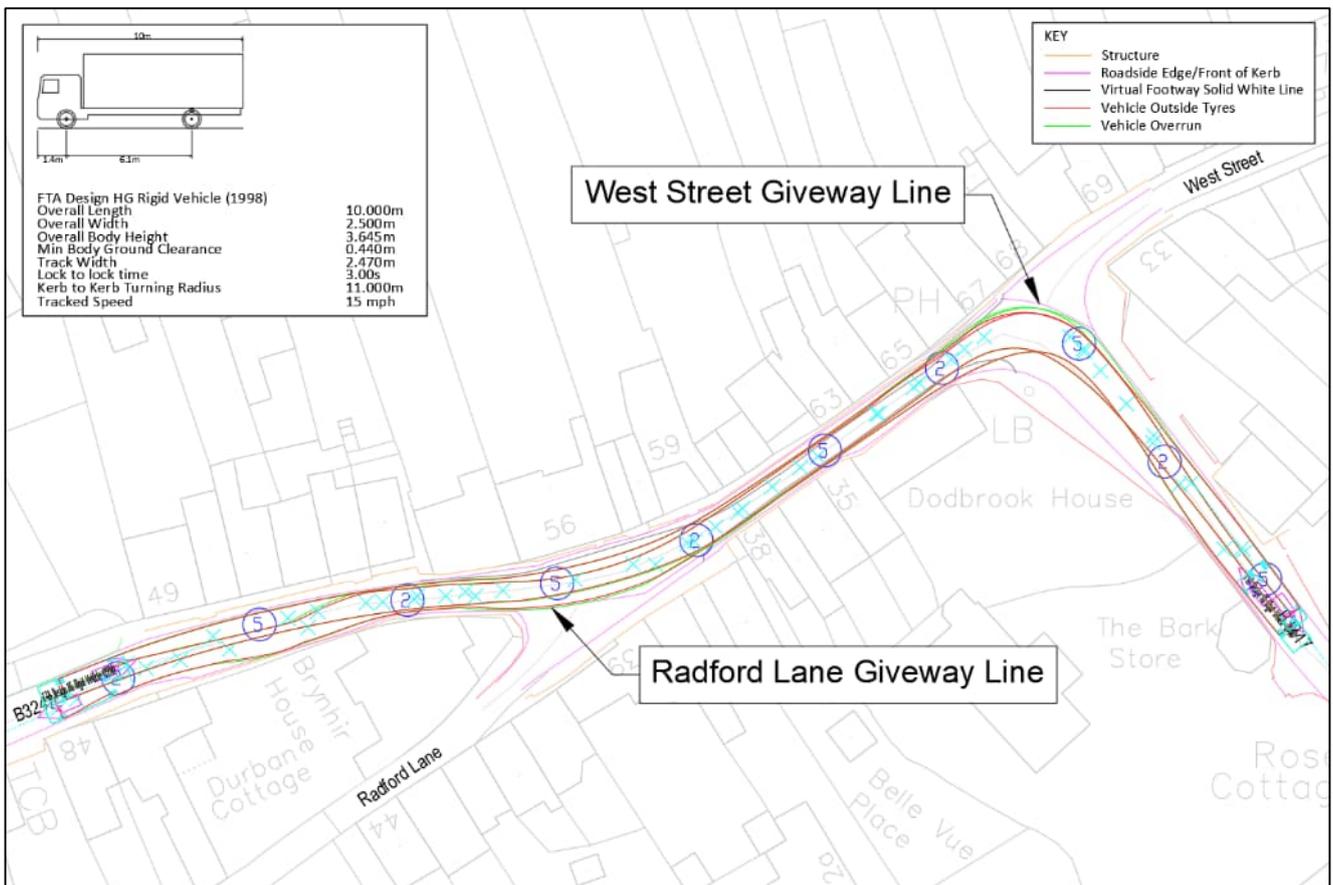
Figure 24 Rigid HGV Tracked at 15mph
