CORMAC

MILLBROOK FEASIBILITY STUDY

FEASIBILITY REPORT

Consultancy | AECOM Limited

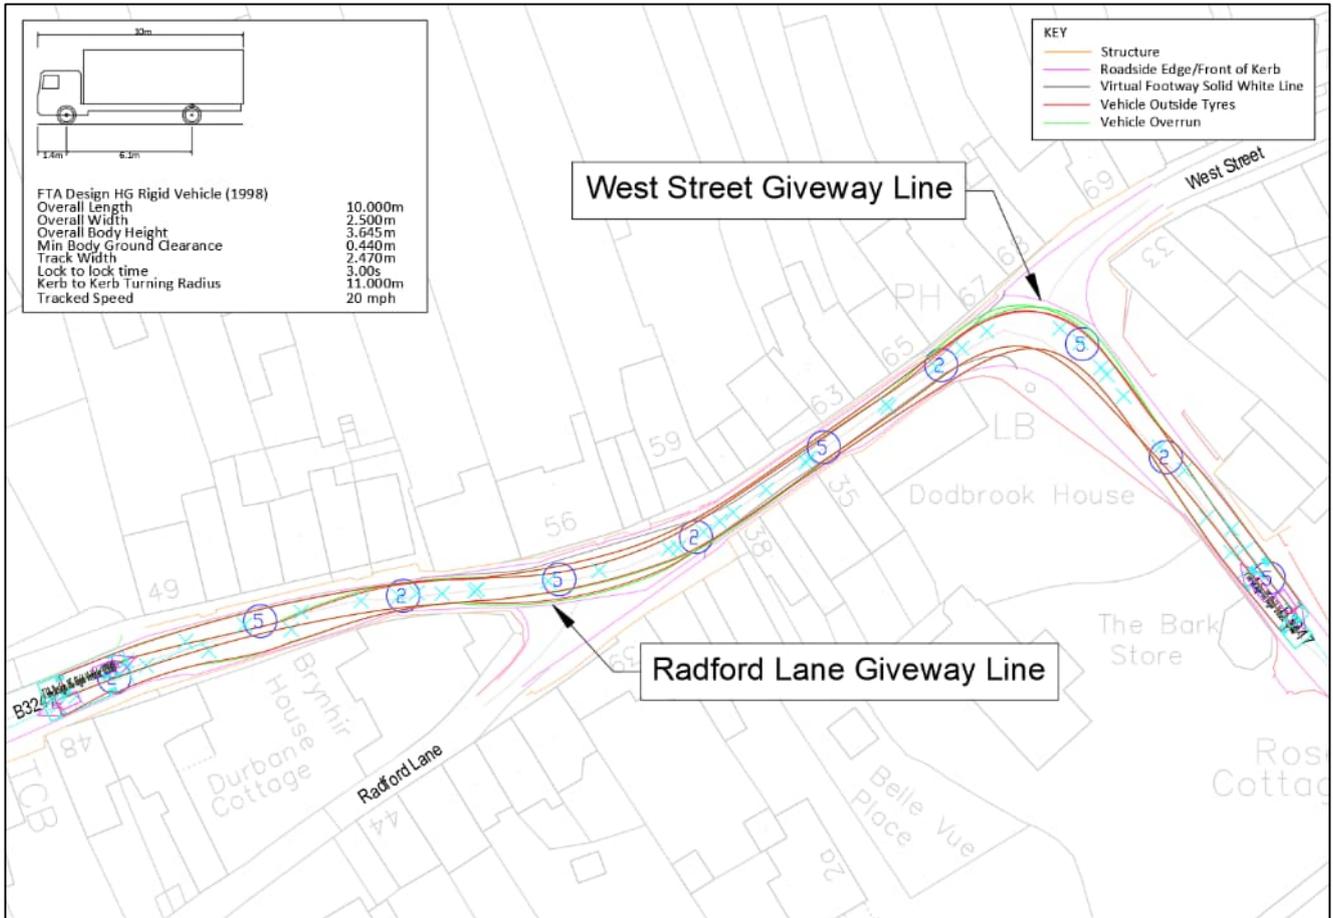
Figure 25 Rigid HGV Tracked at 20mph

Vehicle tracking at the West Street and B3247 junction have been produced for 5mph, 10mph, 15mph and 20mph (excluding the articulated vehicle, which was only tracked at 5 and 10mph) for eastbound and westbound movements. See following [Figures 16 to 25](#).

Compared to the 16.5m articulated HGV and bus, the 10m rigid HGV appears to have no issue with navigating the bend at the B3247 – West Street junction in both directions. At 5mph (see [Figure 22](#)), 10mph (see [Figure 23](#)) and 15mph ([Figure 24](#)), the vehicle appears to have far less trouble navigating the bend at the B3247. On the other hand, like the other two vehicles; at all speeds, the westbound vehicle comes very close to property number 67 and ‘Bar Tusker’. While it appears that at 20mph (see [Figure 25](#)), the vehicle can make the turning manoeuvre at the junction, it appears to come very close to the surrounding structures which is by no means acceptable.

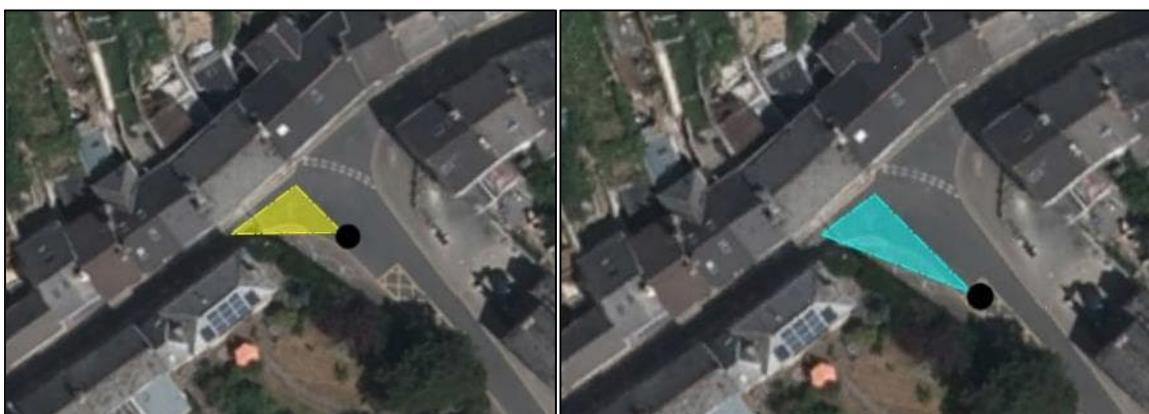
[Figure 26](#) Visibility Splays Turning onto West Street at Junction with B3247; Immediate Junction (left) and Approach to Junction (right)

The constrained horizontal geometry is the key reason for the poor visibility at the B3247 and West Street junction. The wall that is part of an existing property generates a large obstruction, whereby westbound road users are unable to see if any eastbound vehicles are passing through the narrow section of West Street.

The achievable forward visibility is 12m from the immediate junction and 16m on the approach to the junction (see [Figure 26](#)), while the visibility requirement for the existing 20mph speed limit is 45m in accordance with Manual for Streets. There is no other external element to assist the visibility of approaching vehicles.

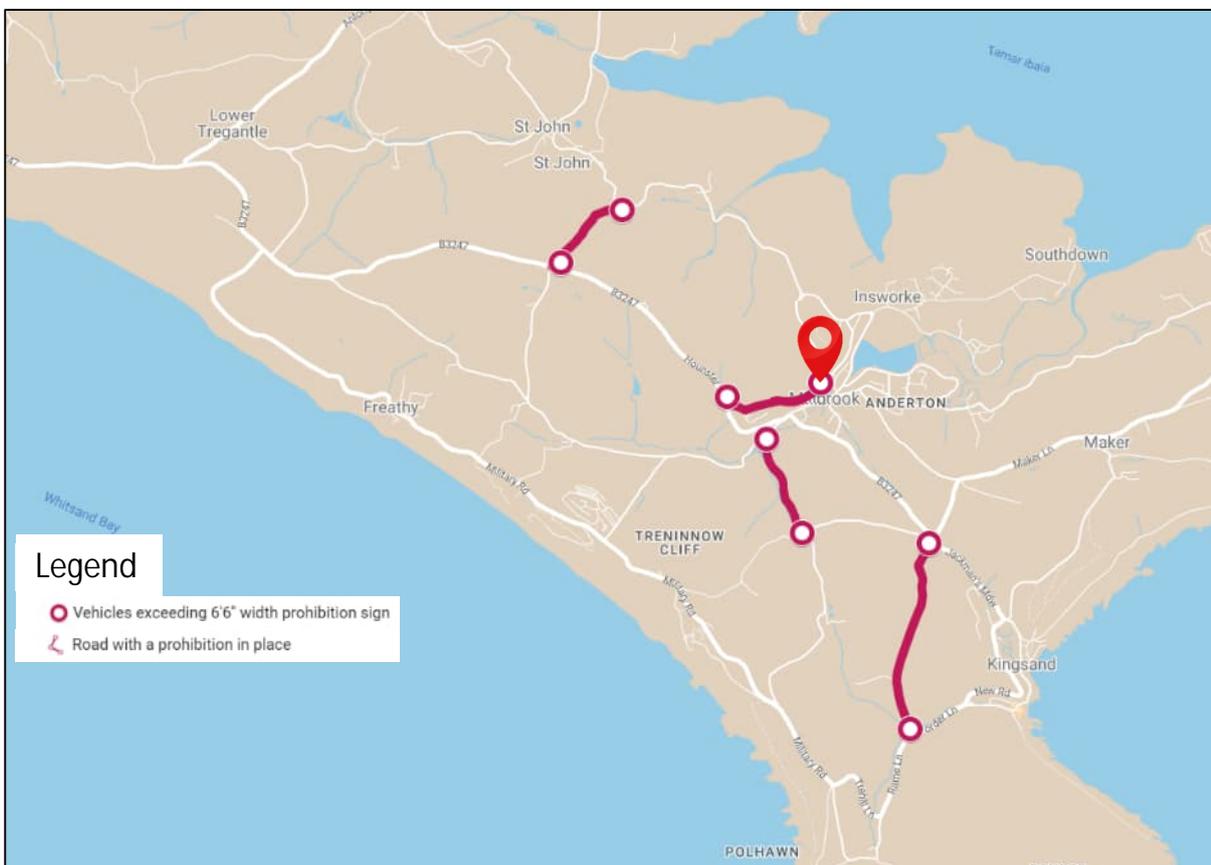
Figure 27 HGVs Prohibition Map (Google Maps)

The roads seen in [Figure 27](#) have official restrictions and/or recommendations for long or wide vehicles in the area.

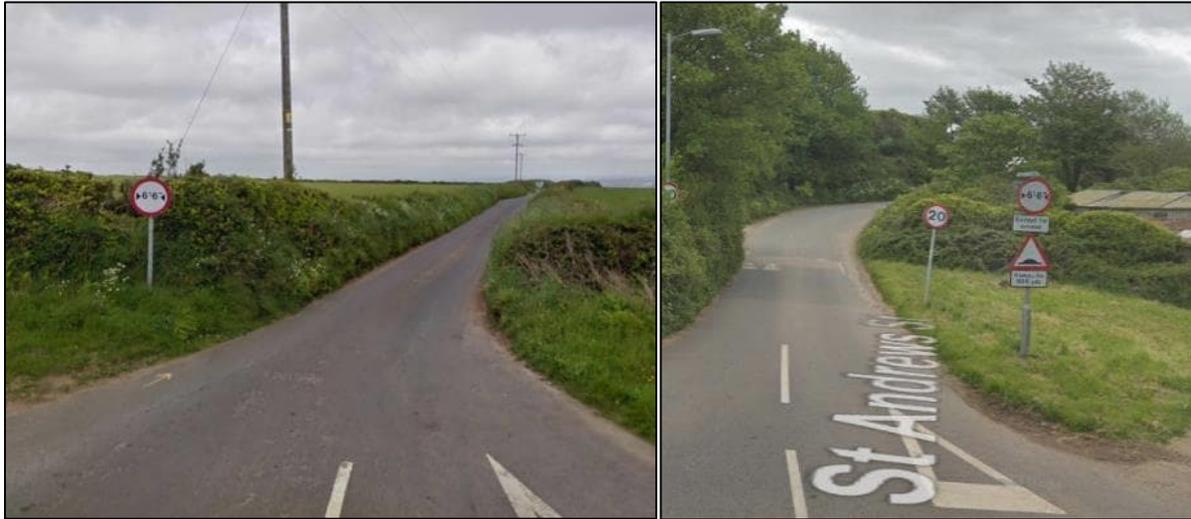
Figure 28 Width restrictions. Withnoe Lane 2017 (left) St Andrews Street 2018 (right) (Google Maps - Street View)

There are existing width restrictions at Withnoe Lane junction with the B3247 and St Andrews Street (see [Figure 28](#)).

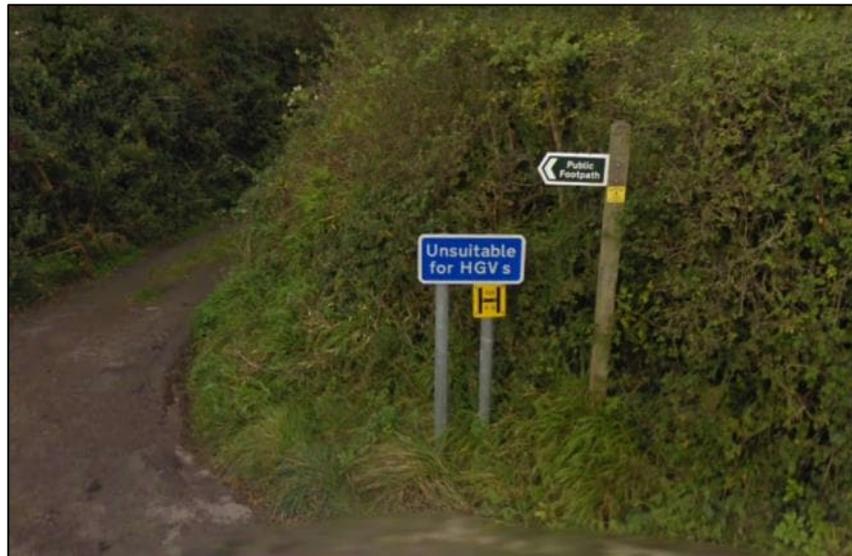
Figure 29 Sign Informing of Road Unsuitable for HGVs (Google Maps - Street View)

Other “Unsuitable for HGVs” signs have also been identified on the surrounding routes, which provide evidence of the routes being unsuitable for HGVs traffic (see Figure 29).

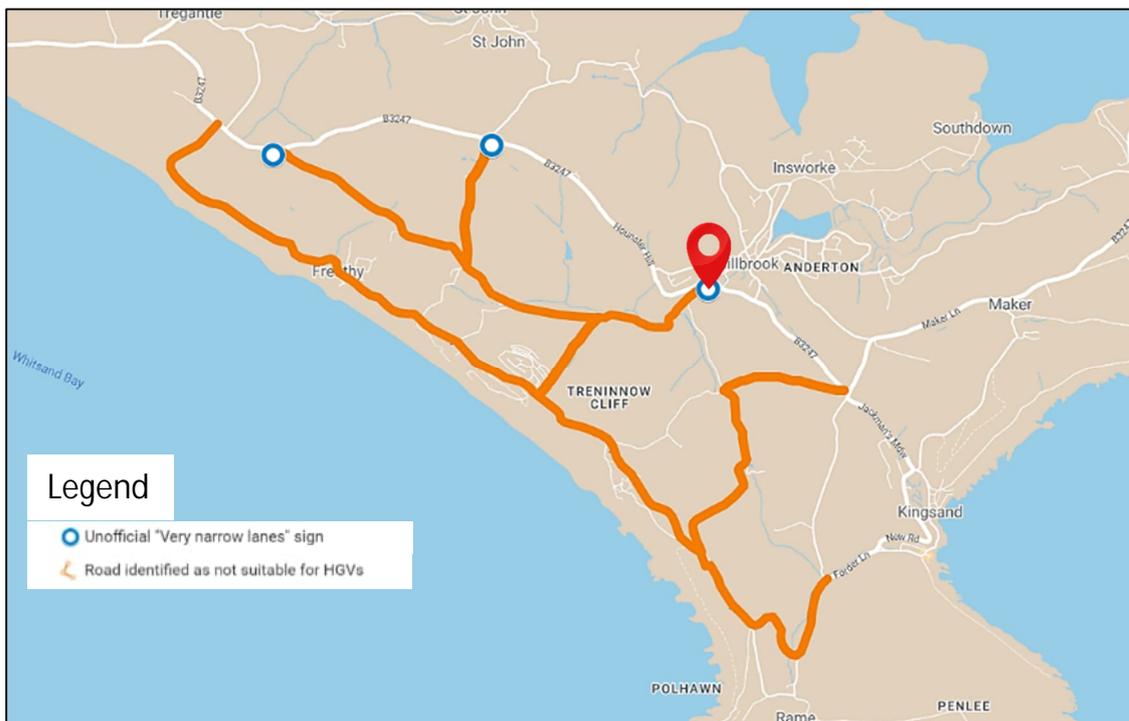
Figure 30 HGVs Road Suitability Map (Google Maps)

A study has been carried out to estimate the suitability of routes for HGVs in the surrounding area. As shown in Figure 30, the findings demonstrates that most of routes are not fit for purpose.

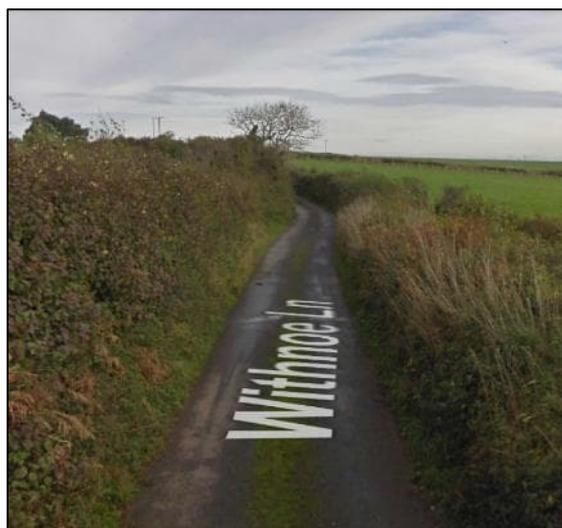
Figure 31 Withnoe Lane (Google Maps - Street View 2009)

Withnoe Lane has been identified as a route that is not suitable for HGVs, as it is a single-track road with existing vegetation that's in very close proximity to the roadside (see Figure 31).

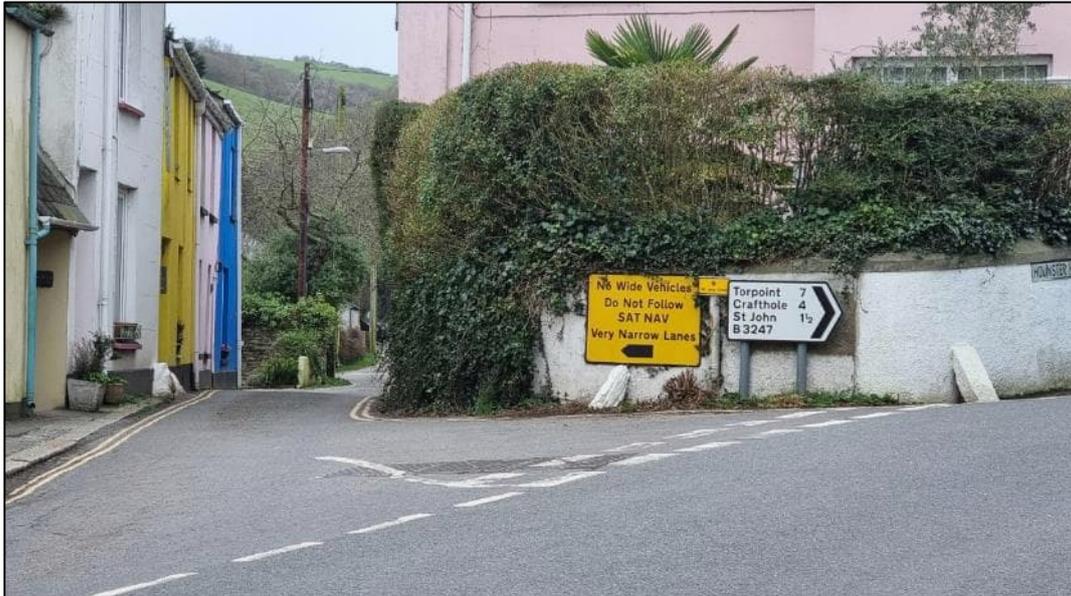
Figure 32 Identified Non-Standard Sign at Radford Lane (Site visit 17/02/2022)

Non-standard signs have been placed at some points to deter wide vehicles from accessing (see Figure 32).

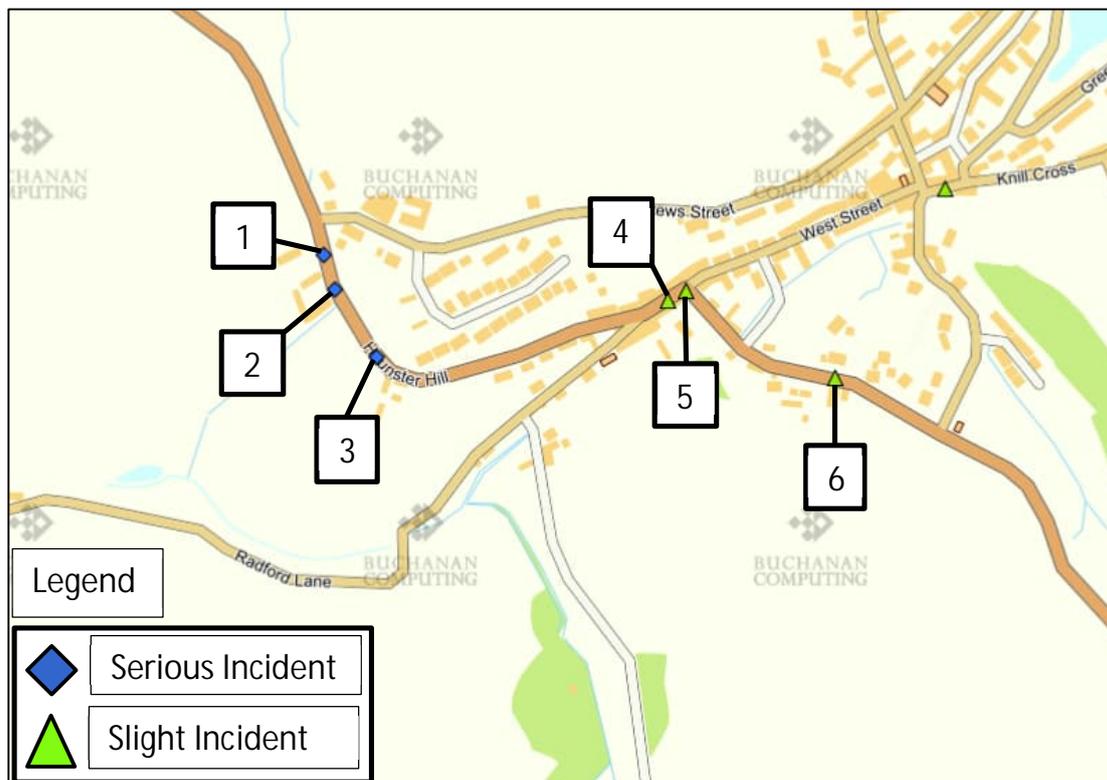
Figure 33 Locations of Incidents Recorded from 2016 to 2021

Collision reports (STATS 19) obtained for the area (as shown in [Appendix C](#)), which date back from 2016 to 2021, identify a total of six recorded incidents that occurred on the B3247 in the Millbrook area. Out of the six incidents recorded, three were reported as 'Serious' injury severity and occurred outside the study area. The remaining three were reported as 'Slight' injury severity, of which two occurred within the study area. Locations of the incidents are indicatively shown in [Figure 33](#).

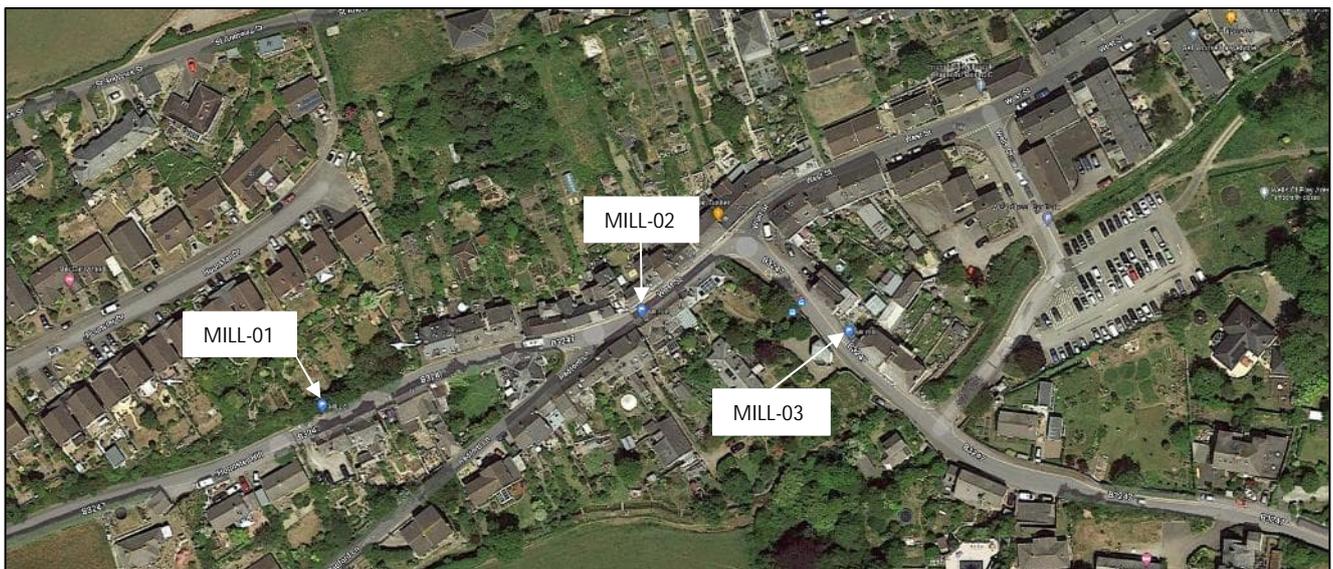
Figure 34 - Automatic Traffic Count (ATC) Survey Locations

Three pneumatic tube counters were located within the study area to determine the vehicle flow in a 7-day, 24-hour period. The study was undertaken in the 2022 Easter School Holidays to ensure it covers a particularly busy seasonal period of the calendar year and a potential worst-case scenario. It is also important to consider that Friday 15th April and Monday 18th April were bank holidays, and therefore may have experienced higher traffic levels than usual. The data collection points were positioned in the following locations, as shown in [Figure 34](#) to [Figure 37](#) and summarised in [Table 1](#).

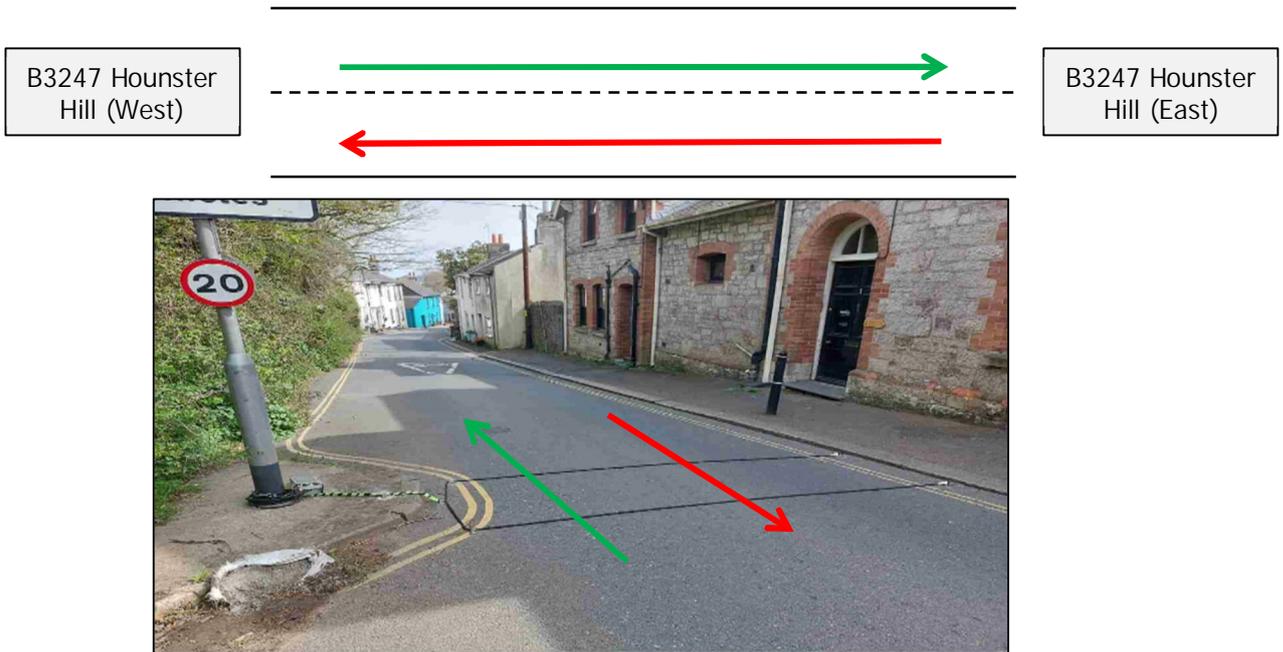
Figure 35 Location of ATC MILL-01 Station

MILL-01: At B3247 Hounster Hill, midway between the section east of the give-way to oncoming traffic sign and west of the junction with Radford Lane, approximately outside property 48-49 (see [Figure 35](#)).

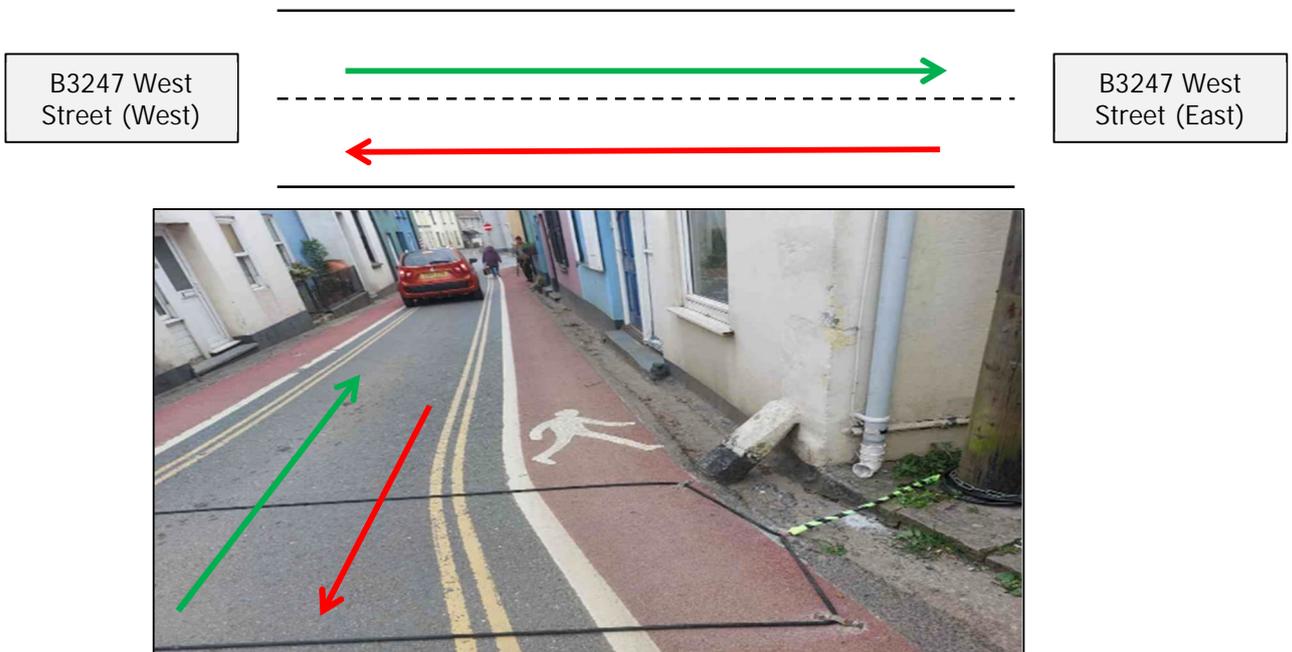
Figure 36 Location of ATC MILL-02 Station

MILL-02: At B3247 West Street, approximately midway between junction with Radford Lane and junction with West Street (see [Figure 36](#)).

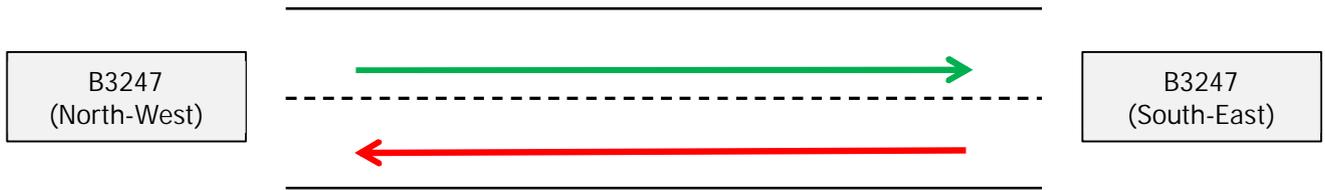
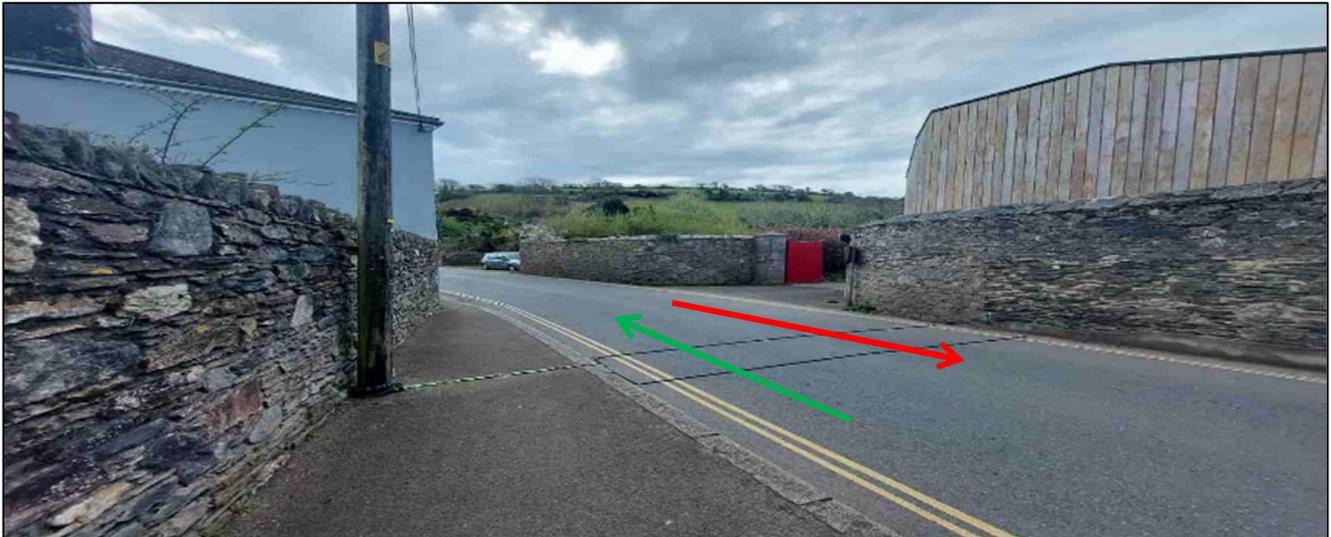
Figure 37 Location of ATC MILL-03 Station

MILL-03: At B3247 West Street, south of junction with West Street and north of bus stop (see [Figure 37](#)).

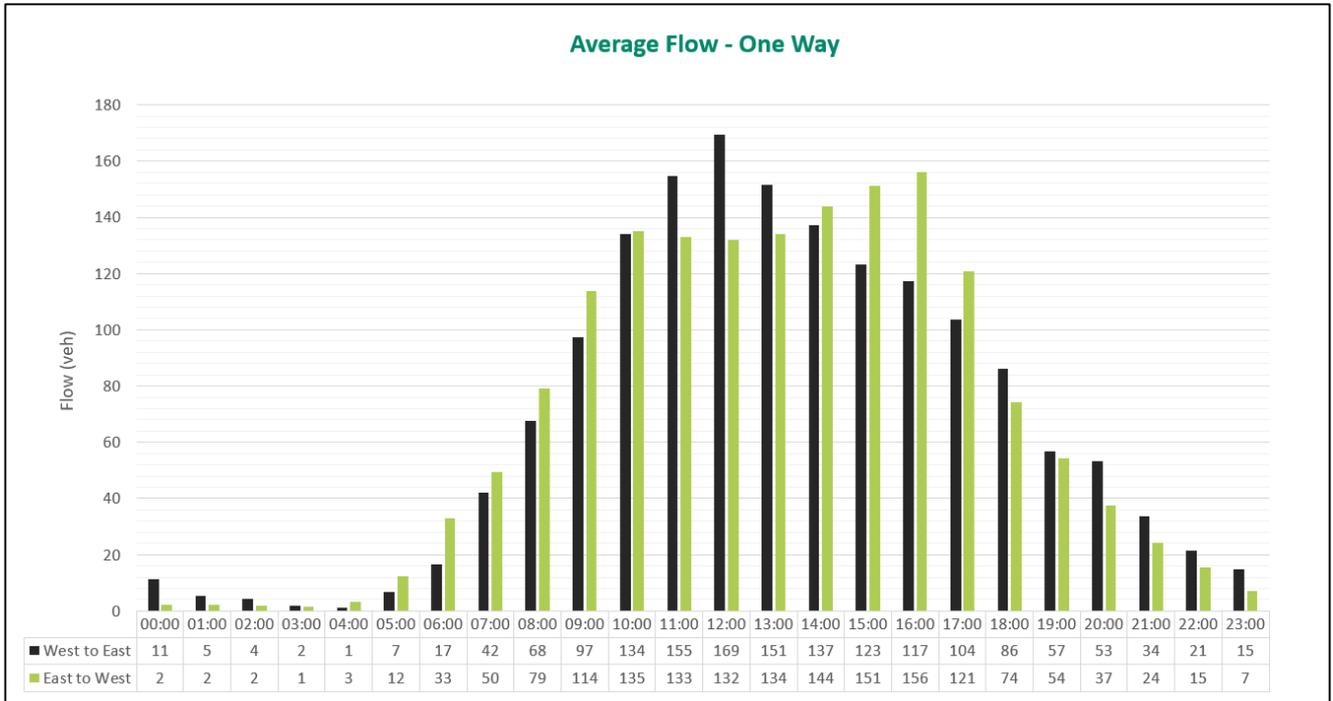
Figure 38 MILL-01 7-day Average Flow - One Way

The following graphs provides the 7-day average flow recorded in each direction (see [Figure 38](#)) and in both directions (see [Figure 39](#)) at station MILL-01.

By looking at the one-way average flow data at stations MILL-01, MILL-02 and MILL-03 (Figure 38, Figure 42 and Figure 46 respectively); it can be established that the time frame that experienced the most eastbound traffic on the B3247 through Millbrook was from 12:00pm to 12:59pm at all 3 stations. Between this time, station MILL-01 had 169 vehicles, MILL-02 164 vehicles and MILL-03 203 vehicles.

The patterns displayed for the single way average flow between stations MILL-01 and MILL-02 appear to be similar, where there are more vehicles heading eastbound from 12:00pm to 12:59pm, and more vehicles heading westbound from 16:00pm to 16:59pm. There is also a pattern from 14:00pm to 16:59pm at both stations, where more vehicles were found to be heading westbound out of Millbrook. Using Table 2, it establishes that around 87% to 88% of the traffic recorded passing eastbound through stations MILL-01 and MILL-02 are cars, signifying the possibility that commuter traffic is either heading to or through Millbrook to work. As the ATC survey took place during the Easter Holidays, tourism may also be a contributing factor to the traffic leaving Millbrook, which may also be responsible for the eastbound traffic levels at 11:00 to 12:59.

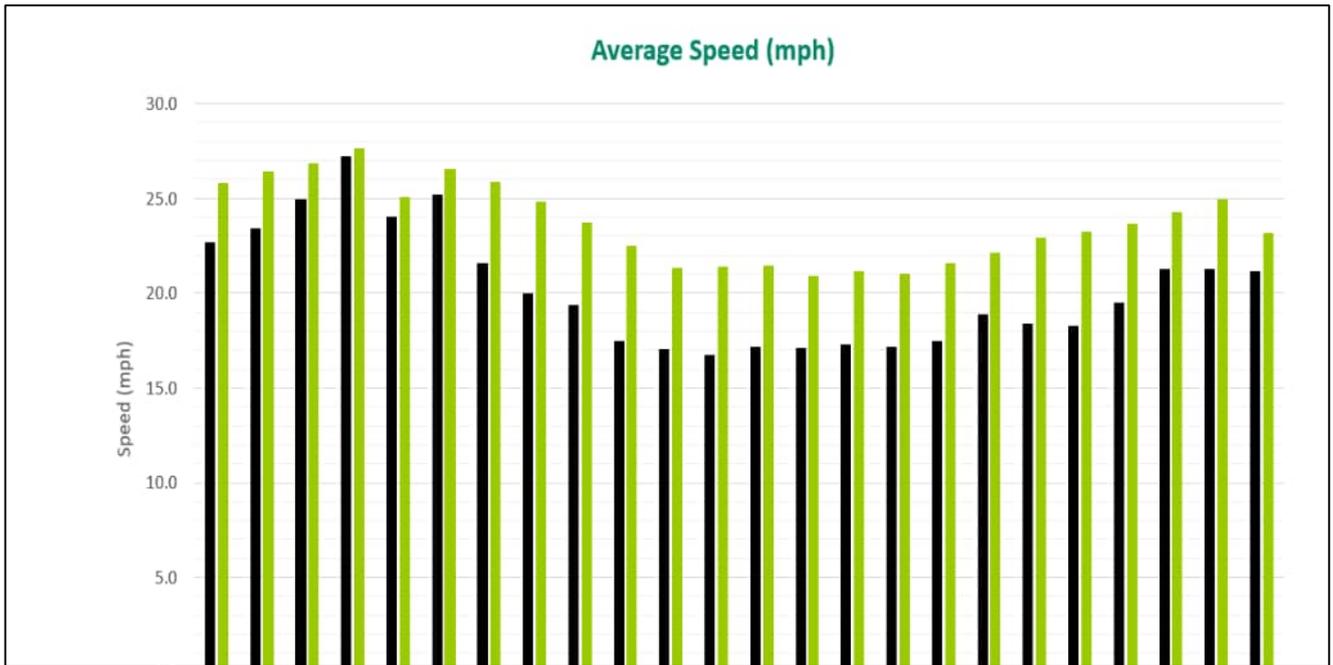
Figure 40 MILL-01 Average Speed (mph)

The following graphs show the average speed in each direction across a single day (see Figure 40), and the mean speed and average 85%ile speed recorded in each direction across the 7-days (see Figure 41) at station MILL-01 for each direction.

By analysing the average speed of vehicles throughout an average day at stations MILL-01, MILL-02 and MILL-03 (Figure 40, Figure 44, and Figure 48 respectively); there appears to be differences in the results between all three stations at all times.

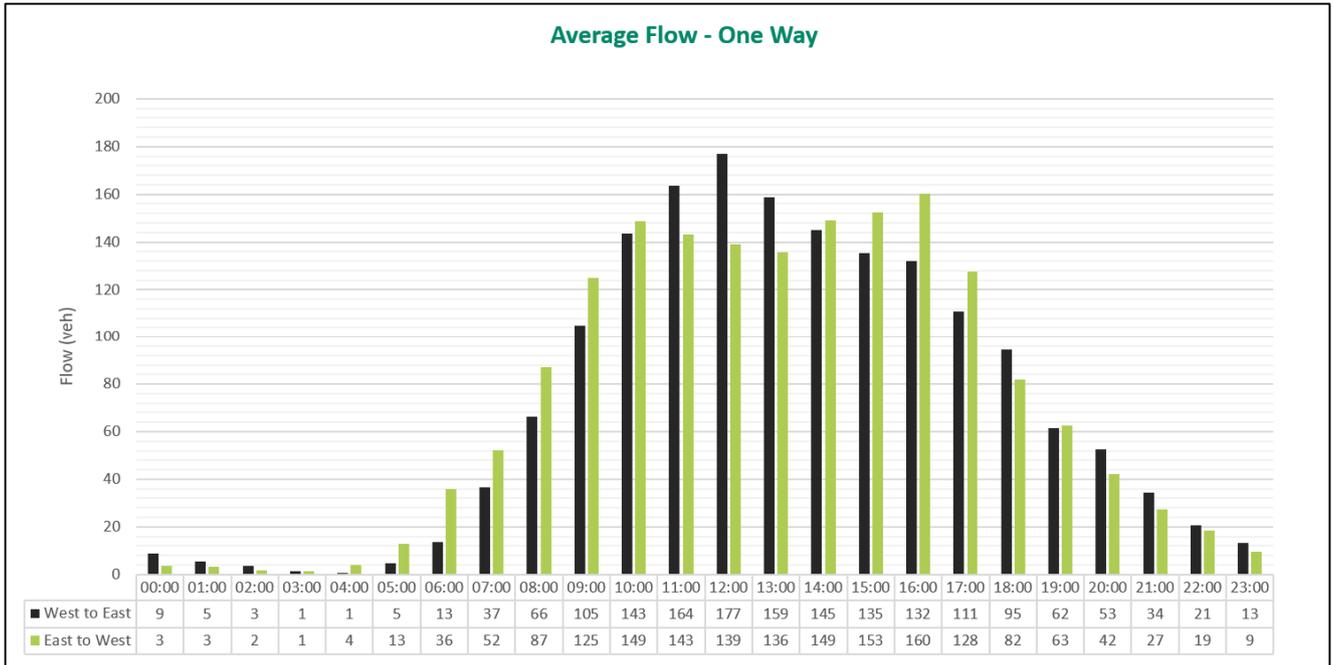
Figure 42 MILL-02 7-day Average Flow - One Way

The following graphs provide the 7-day average flow recorded in each direction (see Figure 42) and in both directions (see Figure 43) at station MILL-02.

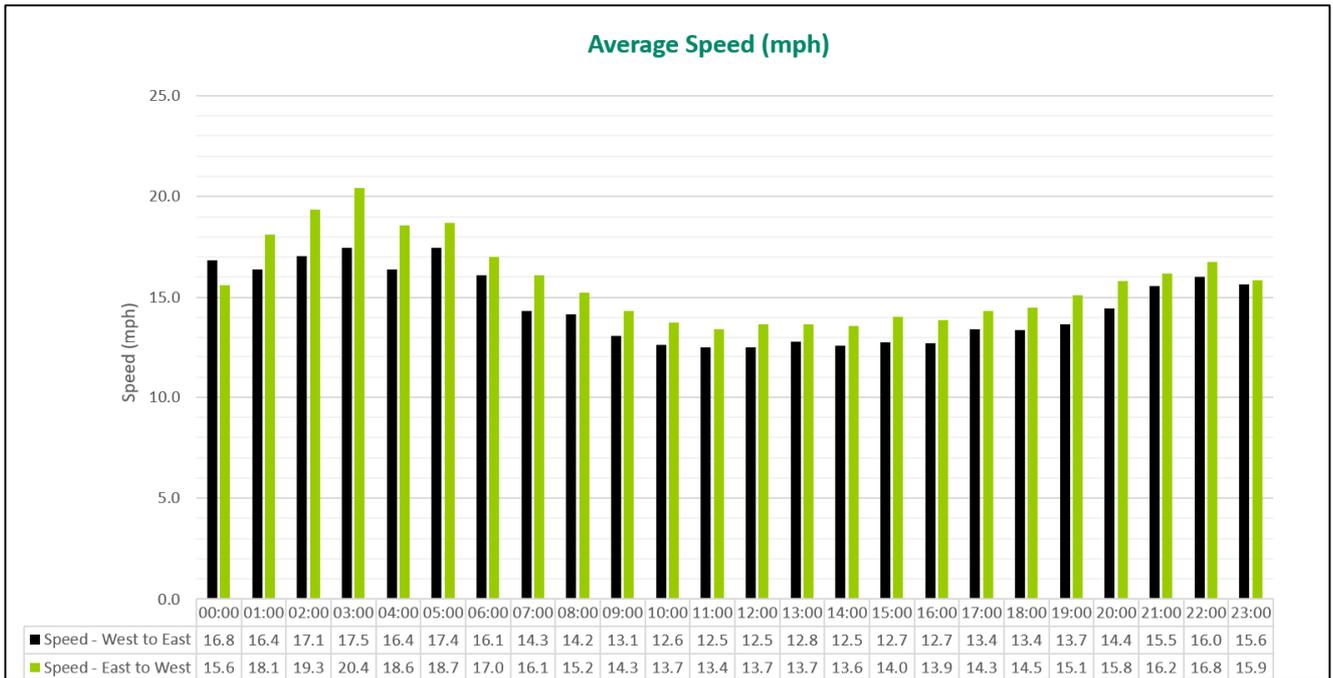
Figure 44 MILL-02 Average Speed (mph)

The following figures show the average speed in each direction across a single day (see Figure 44), and the mean speed and average 85%ile speed recorded in each direction across the 7-days (see Figure 45) at station MILL-02.

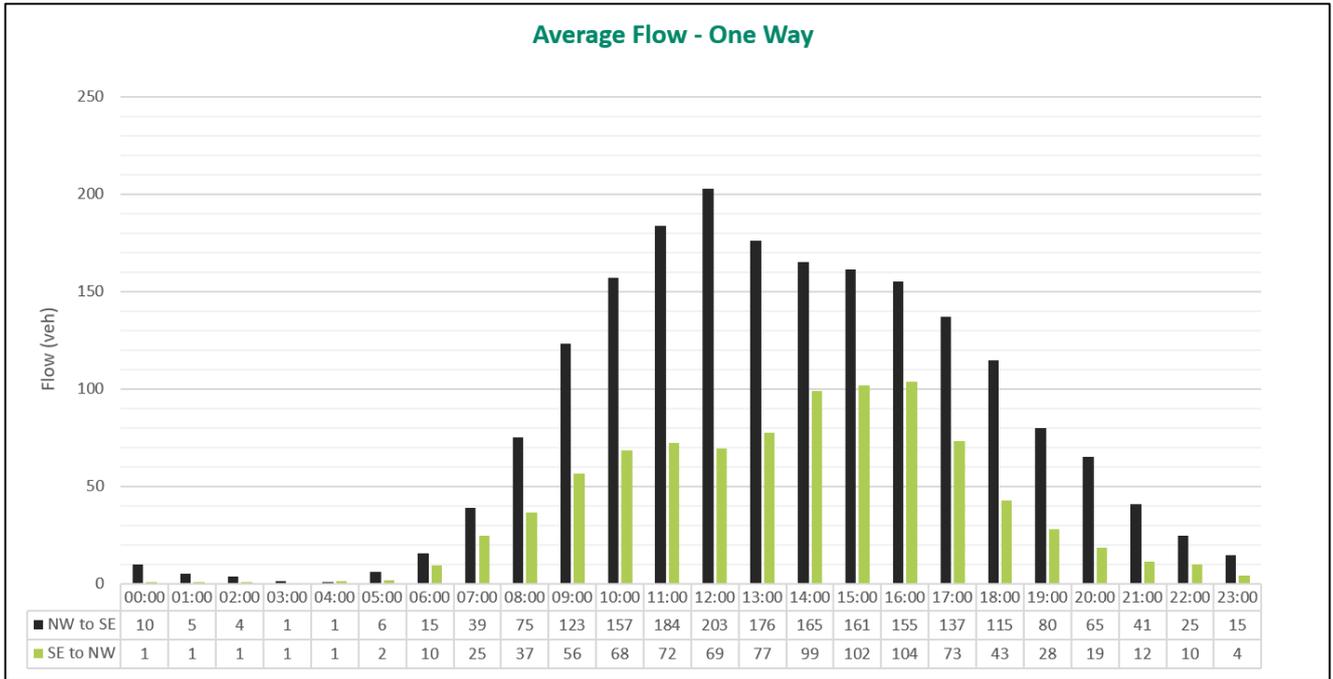
Figure 46 MILL-03 7-day Average Flow - One Way

The following graphs provide the 7-day average flow recorded in each direction (see Figure 46) and in both directions (see Figure 47) at station MILL-03.

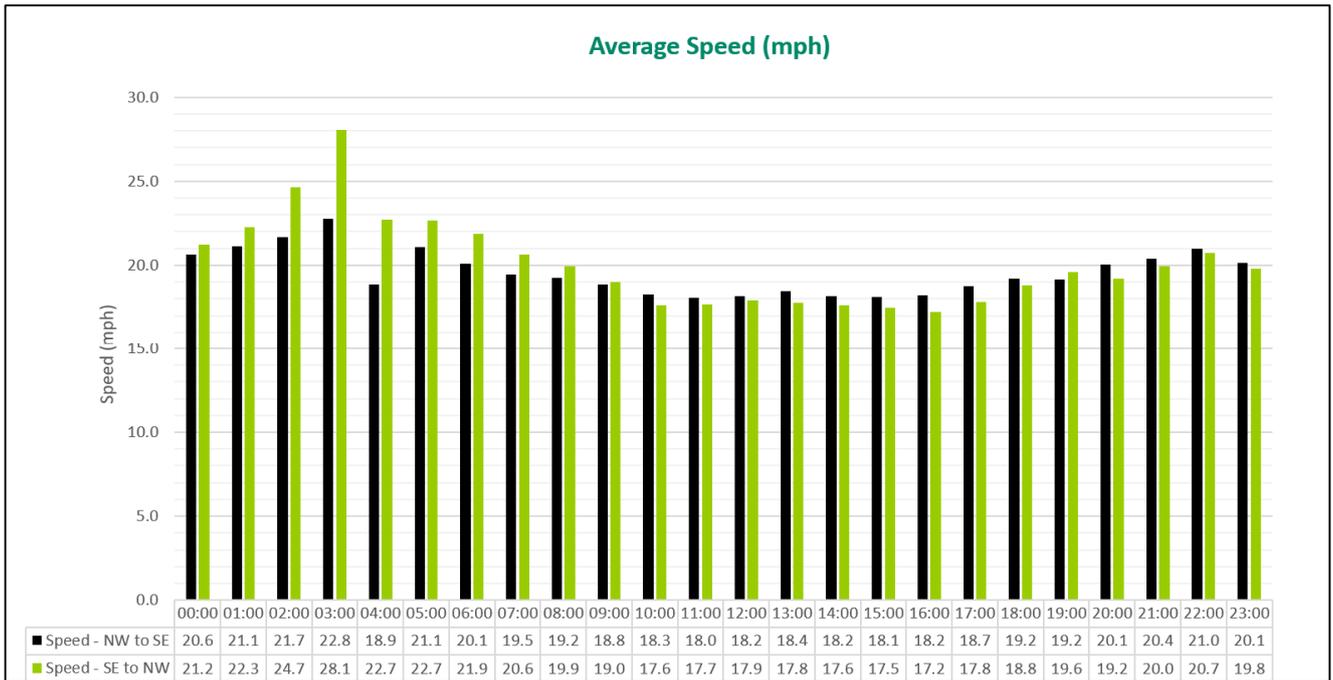
Figure 48 MILL-03 Average Speed (mph)

The following figures show the average speed in each direction across a single day (see Figure 48), and the mean speed and average 85%ile speed recorded in each direction across the 7-days (see Figure 49) at station MILL-03.

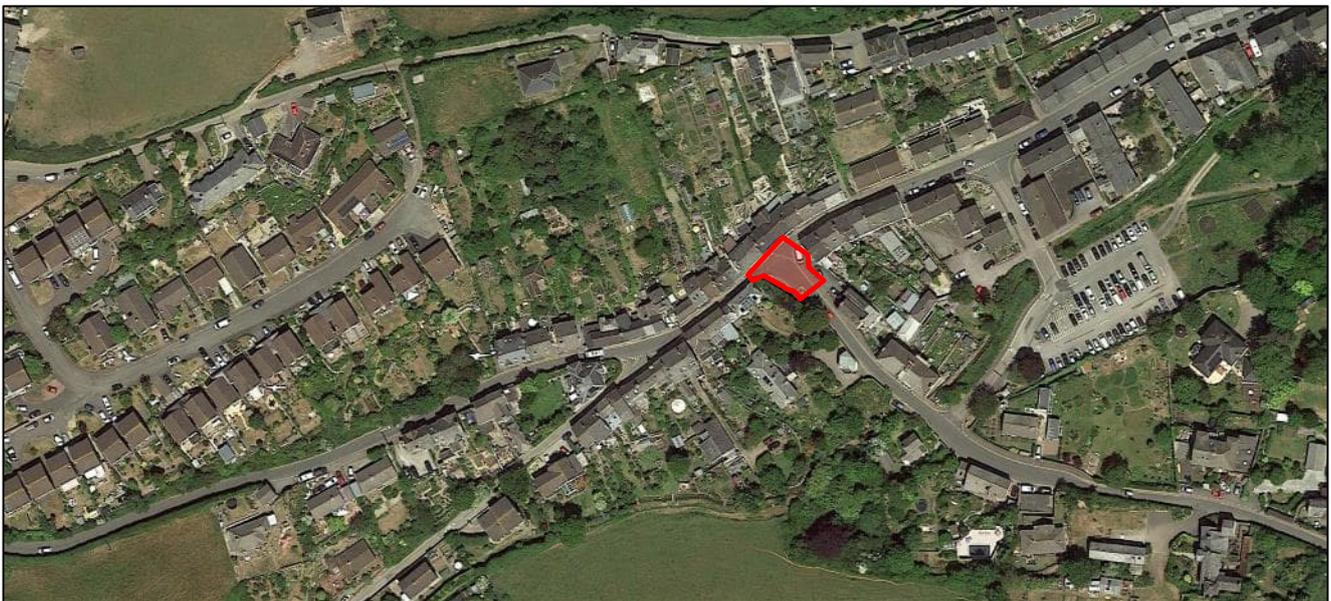
Figure 50 Camera Survey Location

A camera survey operating for 24 hours a day for 7 days was undertaken at the B3247 – West Street junction (see [Figure 50](#) and [Table 9](#)) during the same period which the ATC survey was conducted. Similarly, to the ATC, the study was carried out in the 2022 Easter School Holidays to ensure it covers a particularly busy seasonal period of the calendar year and covers a potential worst-case scenario. It is also important to consider that Friday 15th April and Monday 18th April were bank holidays, and therefore may have experienced higher traffic levels than usual.

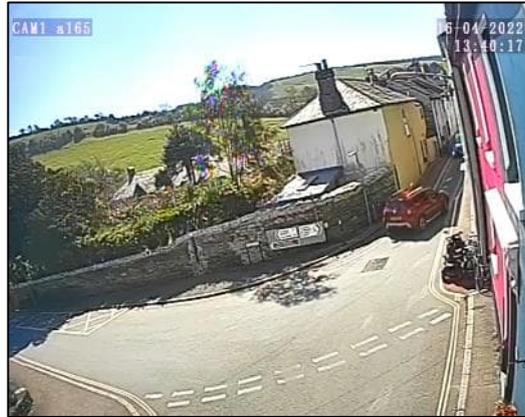
Figure 51 Westbound Car Interaction

All figures in this section are screen captures of various points in the camera survey footage which are of interest. The following figures present instances of interaction between the B3247 eastbound and westbound traffic.

By reviewing the figures relating to the interactions between vehicles at the junction, it appears to further support the issue regarding poor visibility on both the eastbound and westbound B3247 approaches, where vehicles are seen to come face on with vehicles travelling in the opposite direction. An example is presented in [Figure 51](#), where a vehicle heading westbound comes face on with a vehicle travelling eastbound at the opening of the bend. The most common reaction observed in the camera survey during this scenario was the same as those found during the on-site observations, where the westbound vehicles were stopping and reversing back around the bend to allow the eastbound vehicles to pass. While this appears to be the only suitable outcome, it may lead to another scenario where the westbound vehicle is at risk of colliding with another vehicle that's approaching from behind, where the driver may not have observed the manoeuvre, either possibly due to poor forward visibility around the bend or from a late reaction.

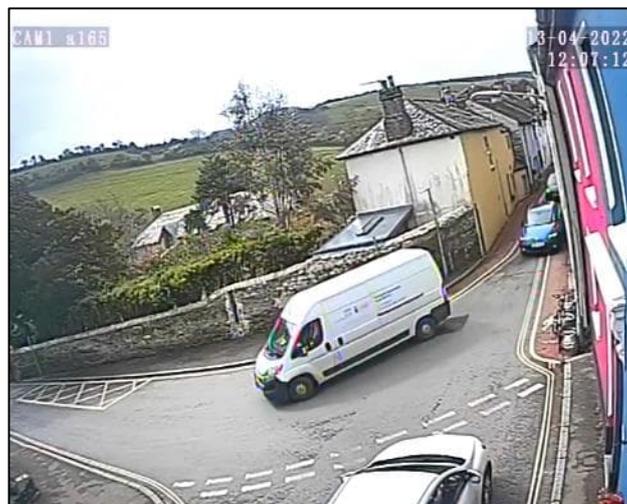
Figure 57 Eastbound Car Driving Over Virtual Footway

The following figures present instances of vehicles driving over the virtual footway on the B3247 West Street in both directions.

Expanding on the safety of pedestrians, [Figure 57](#), [Figure 58](#) and [Figure 59](#) show examples of vehicles overrunning the virtual footway. While it could be argued that the overrun shown by the car in [Figure 57](#) could have been mitigated by the driver; [Figure 58](#) and [Figure 59](#) show overrun on both sides of the vehicles, indicating an unavoidable scenario for certain vehicle

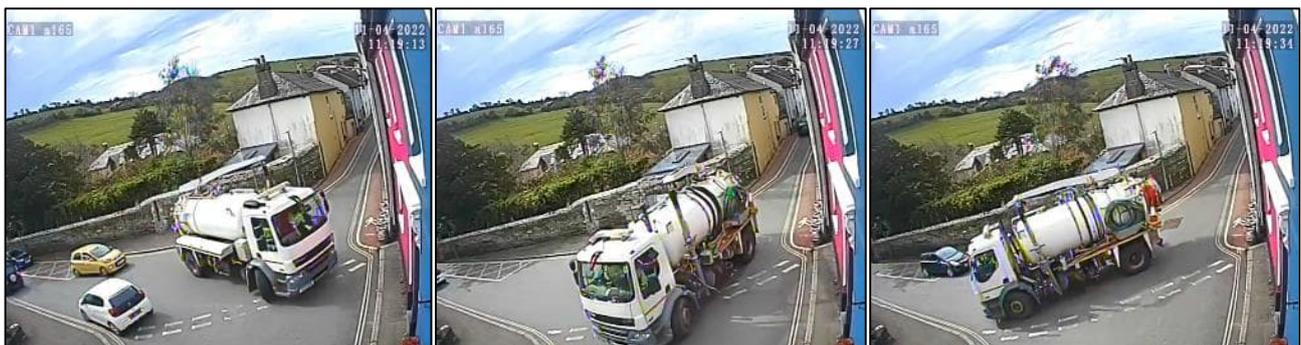
Figure 60 2 Axled Rigid HGV doing a U-Turn at the B3247 – West Street Junction

The following figures present examples of a vehicle doing the U-Turn and another unloading at the B3247 and West Street junction.

Figure 60 shows an example of a vehicle doing a U-turn at the junction, using the West Street arm to turn into. While a driver of the vehicle may have sight of a vehicle waiting at the West Street arm, it is observed that there is inadequate visibility to see vehicles approaching the junction further up West Street. This may risk a collision with the vehicle pulling in to make the U-turn, as the vehicle may likely overrun the give-way line to have enough space to make the manoeuvre.

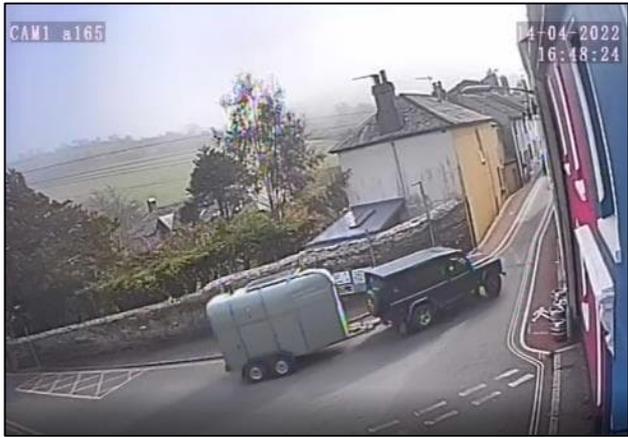
Figure 62 Car Towing a 2 Axled Trailer

The following figures present examples of vehicle types travelling across the B3247 – West Street junction during the duration of the camera survey.

Figure 62, Figure 63, Figure 64, Figure 65 and Figure 66 present additional examples. Figure 62 presents a car towing a 1 axled trailer, where in the ATC data, it is suggested that this vehicle may have been categorised as an 'LGV' and not a 'Car'. Figure 63 presents a similar situation, where in the ATC data, it is suggested from the survey that this vehicle was categorised as a '3 Axled Articulated' vehicle and not an 'LGV'. As there were various other examples of this captured, it is important to consider that the camera survey appears to highlight inconsistencies within the ATC data, where there are vehicles that may have been categorised incorrectly, and therefore may have resulted in an added increase or reduction in vehicle types throughout the different times and days.

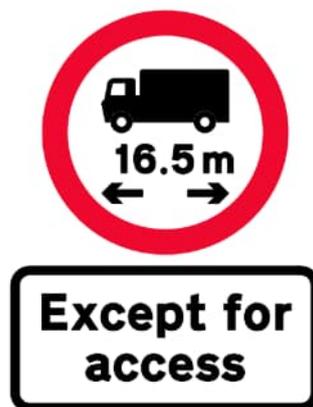
[Figure 67](#) Example of Sign used for 16.5m Length Restriction

A Traffic Regulation Order (TRO) restricting the longest vehicles from using West Street, if adhered to and/or enforced, would reduce the use of West Street by long HGVs. It is suggested that a length restriction for 16.5m long HGVs is consulted, and to not restrict local agriculture usage, a supplementary plate “Except for access” should also be used alongside the length restriction (with an example of signage shown in [Figure 67](#), in accordance with TSRGD Schedule 12, Part 20, Item 33 and Schedule 3, Part 3, Item 15). This is due to the long HGVs being the main cause of property damage due to their large turning radiuses as evidenced from the vehicle tracking and damage reports.

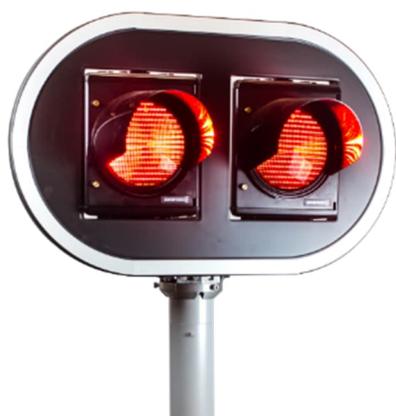
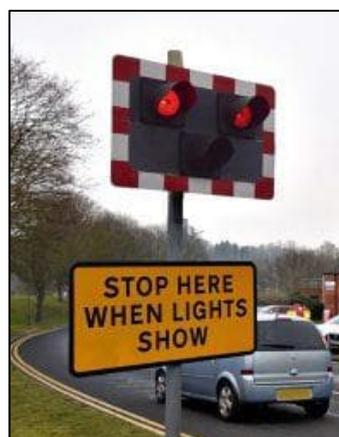
Figure 68 Examples of Wig-Wag Warning Lights

ITS measures could however be used to fully mitigate all vehicle conflicts on West Street through implementing Wig-Wag flashing warning lights positioned on the northbound approach to the B3247 - West Street junction. These would be similar to warning light systems used for level crossings. A detector could be placed on Hounster Hill, prior to the narrow section, and any motorised vehicles passing over it would trigger warning lights or a Variable Message Sign (VMS) on the B3247 alerting drivers to stop at a give-way marking. Signage and lining to support the measure would also need to be implemented, possibly the relocating the existing yellow box to the centre of the junction ahead of the give way lines. See [Figure 68](#) for examples of Wig-Wag lights and [Figure 69](#) for a potential location on the nearside pavement (setback 450mm) adjacent to give way markings.

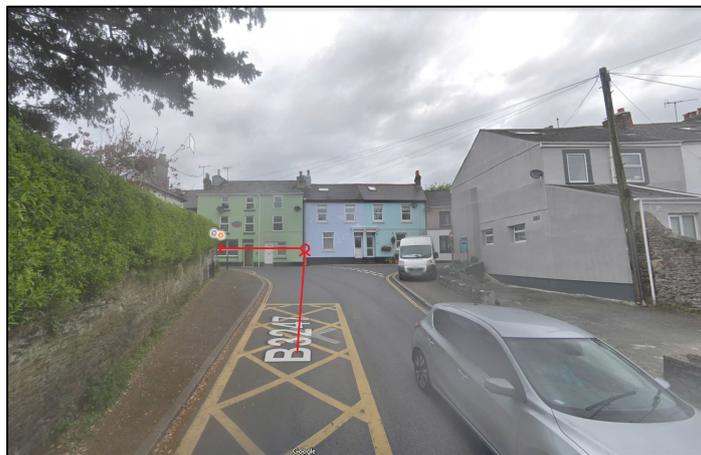
Figure 70 Suggested Location of Road Traffic Mirror on westbound B3247 approach to West Street Junction on Existing Lighting Column

The use of a concave road traffic mirror on the B3247 east approach of the B3247 - West Street junction may assist in improving the visibility of oncoming eastbound traffic and pedestrians around the bend, which should allow vehicles who are approaching the bend from the east to stop and give way to oncoming traffic. Therefore, it reduces the likelihood of a conflict. A suggested location to install a road traffic mirror is on an existing lighting column located directly in front of the oncoming westbound traffic on the B3247 who are approaching the bend (where location is shown indicatively in [Figure 70](#))
