CORMAC

MILLBROOK FEASIBILITY STUDY

FEASIBILITY REPORT

Consultancy | AECOM Limited

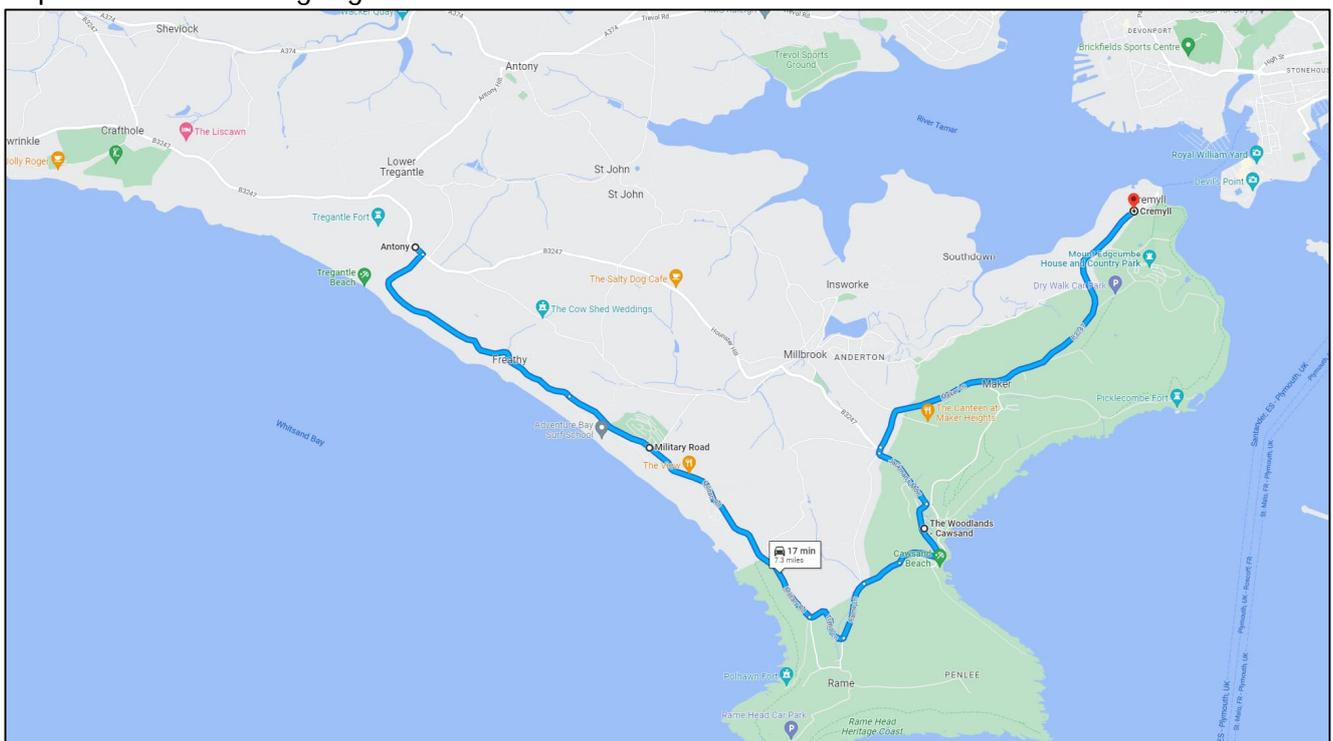
Figure 71 Diversion of Traffic along Military Road (Google Maps 2022)

The use of these locations on the directional signs located at the B3247 – Military Road junction could help in diverting traffic away from Millbrook by using Military Road (See [Figure 71](#)), which may result in a reduction to the general traffic heading through Millbrook. It is also a potential low-cost measure to implement, as it would only require the design and implementation of signage.

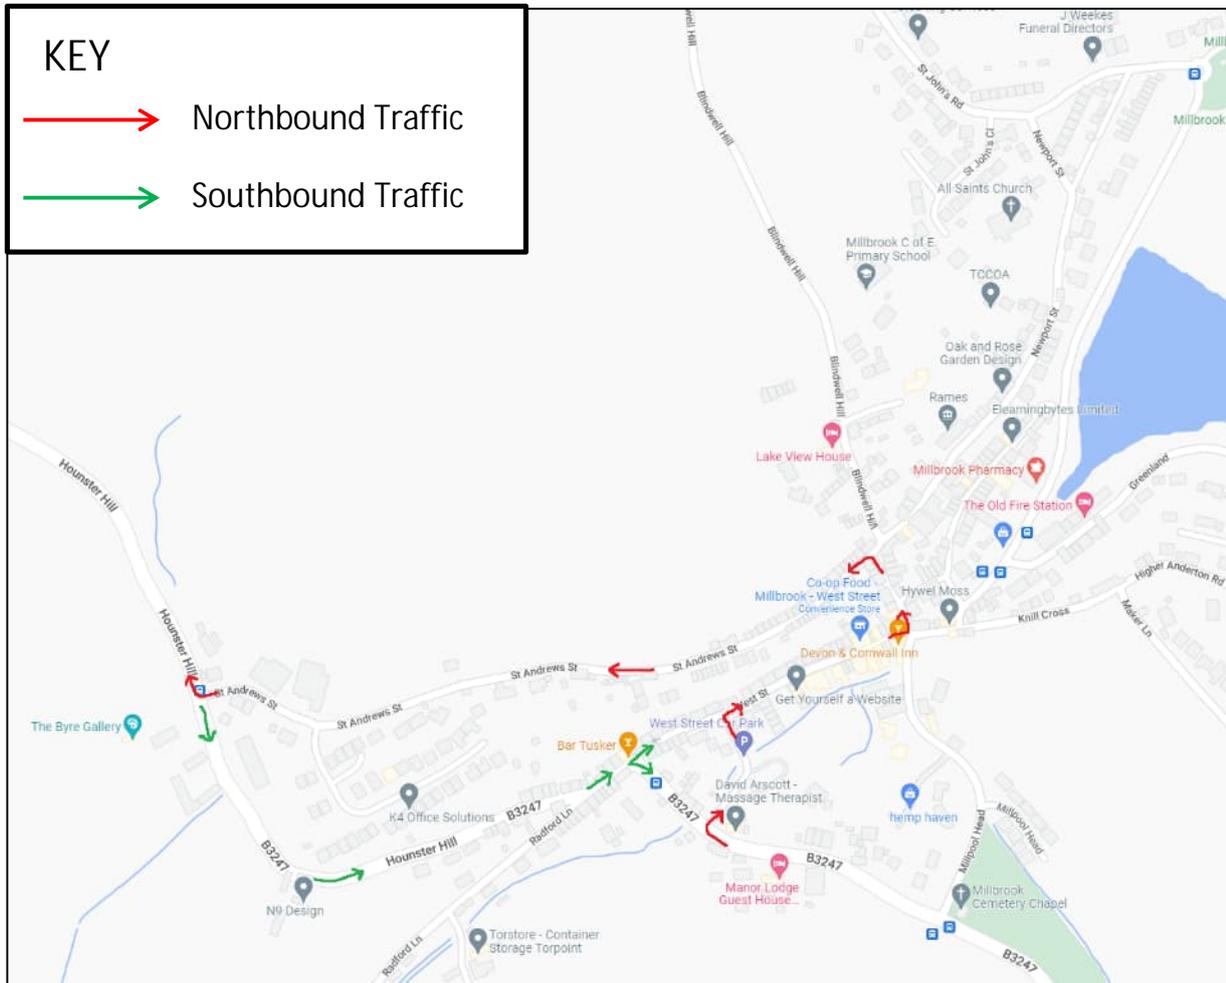
Figure 72 Proposed Direction of One-Way System (Google Maps 2022)

This option proposes the use of West Street Car Park (Wells Court), West Street, Fore Street and St Andrews Street (see [Figure 72](#)) as a one-way route for B3247 northbound traffic. The B3247 southbound traffic would use Hounster Hill and West Street. The northbound route aims to divert HGVs and general traffic to use a separate route that significantly reduces the conflict with the B3247 southbound traffic.

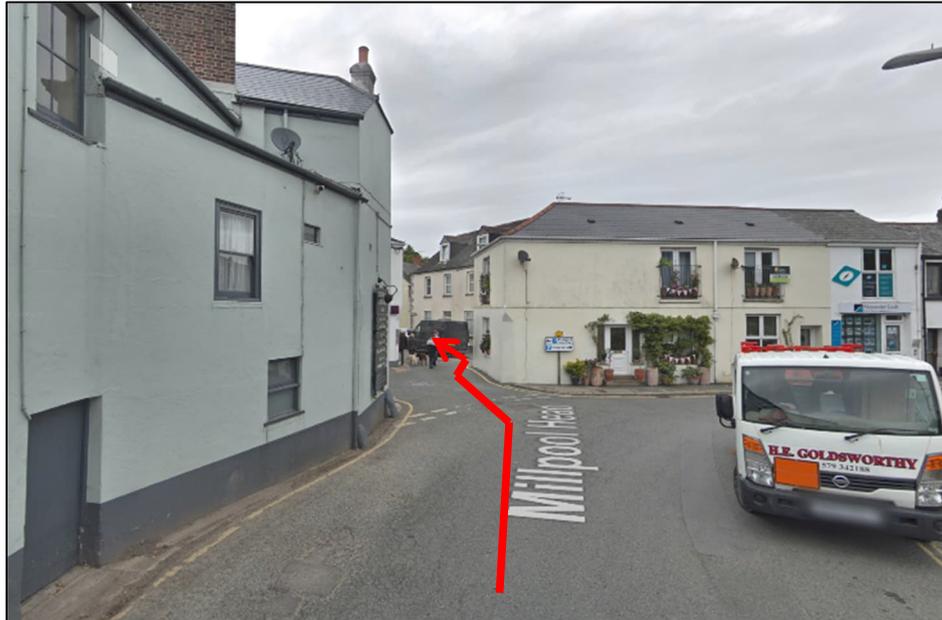
Figure 77 Millpool Head to Fore Street (Google Maps 2022)

The use of Millpool Head to reach Fore Street (see [Figure 77](#)) has also been investigated and while it does bypass the use of the bridge on Wells Court, the vehicle movement that's required to reach Fore Street contains issues with visibility and vehicle clearance. This is likely to result in conflicts with NMUs and vehicle strikes to the surrounding structures.

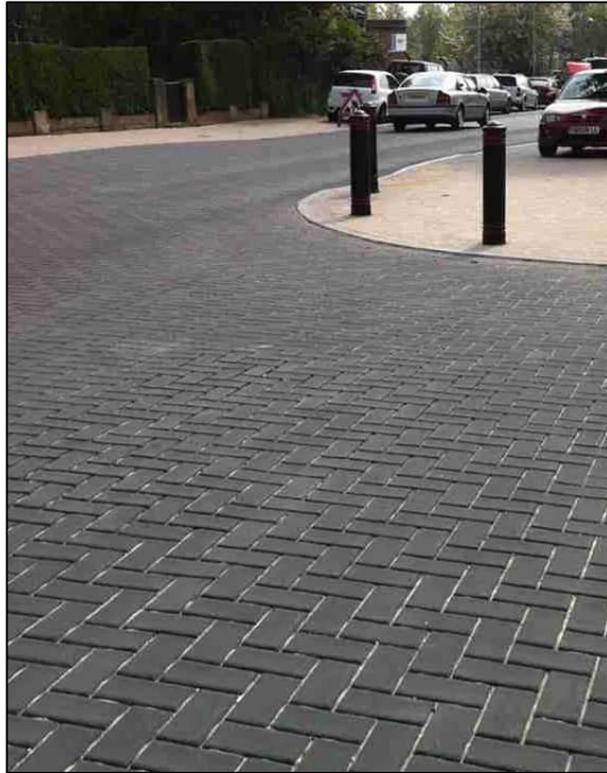
Figure 78 Example of an Imprinted Bitumen Surface (HMS Limited)

A level surface (a type of shared road space) could be implemented using imprinted bitumen (see Figure 78) and granite flagstones to mark out the extents of the area. The texture and visual effect may help to reduce the speed of vehicles and make motorists more aware of NMUs in the area. The at-grade aspect of the level surface could also help in prioritising NMU movements.

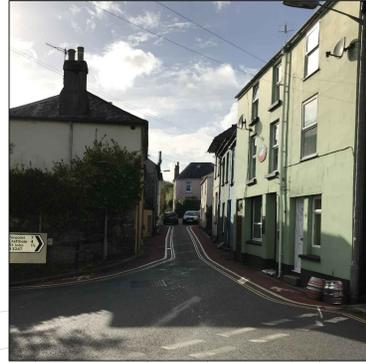
NARROW SECTION OF CARRIAGEWAY(4m WITH 1m VIRTUAL PAINTED FOOTWAYS), VEHICLES UNABLE TO PASS EACH OTHER ALONG

PUB LOCATED ON WEST STREET - LIKELY TO GENERATE PEDESTRIAN DEMAND AND ALSO REQUIREMENTS FOR DELIVERIES

SHARP 90 DEGREES BEND WITH BLIND CORNER

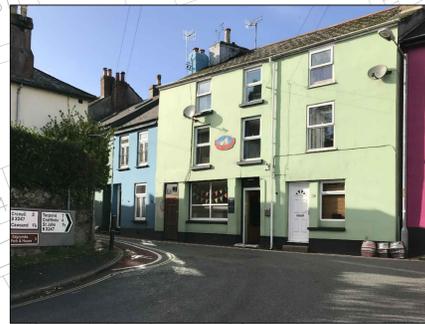
POOR VISIBILITY WHEN TRAVELING EAST

LOCALISED PINCH POINTS - LEADING FURTHER DIFFICULTIES WITH VEHICLES PASSING EACH OTHER

PRIORITY TO THE EASTBOUND VEHICLES FROM THIS POINT

HGVs DIFFICULTY TO TURN WESTBOUND CAUSING DAMAGE TO THE ADJACENT PROPERTIES
